**A Pilot Project Report
Concerning Horizontal Roughing Filtration**

**THE REHABILITATION OF THE WATER TREATMENT SYSTEM
OF THE RURAL COMMUNITY OF COCHARCAS
HUANCAYO/JUNIN
PERU**

**July
1986**

**DELAGUA LTD
PUBLIC HEALTH CONSULTANTS
CEPIS/PAHO/WHO LIMA**

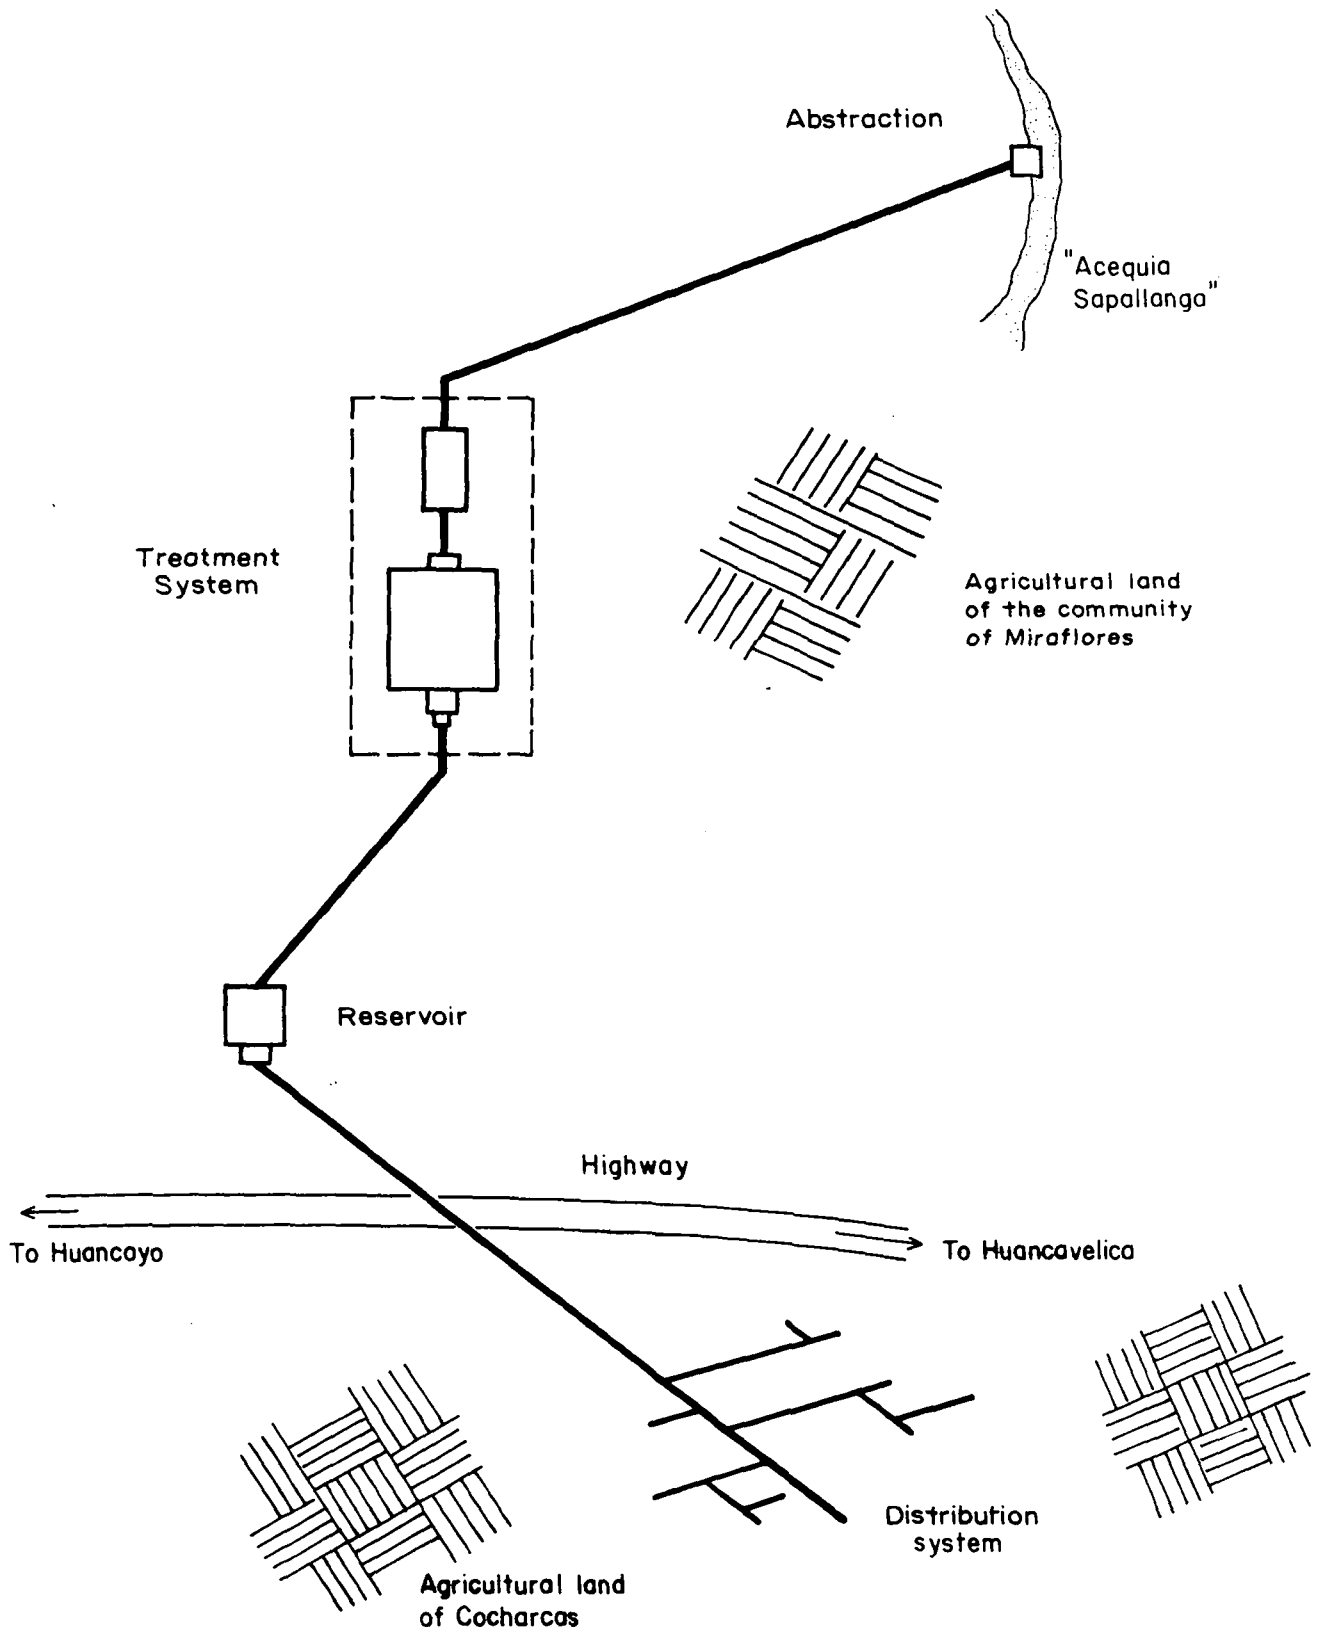
Figure 2. SCHEMATIC DRAWING OF THE WATER SUPPLY SCHEME OF COCHARCAS

The first contact with the community was made in mid-September of 1985. The system then worked only for 2-3 hours per day, a situation due to the fact that: i) the water source was the property of a neighbouring community, and ii) there was no flow control mechanism and thus an indiscriminate amount of water was being abstracted. This resulted in constant interference as described in the introduction under "abstraction problems". The caretaker was only concerned with filling up the reservoir and as a consequence the plant was badly overloaded and no treatment occurred. Figure 3 shows the granulometric characteristics of the 30 cm layer of sand in the SSF. The community was led to believe that the solution to the problem was to build another reservoir. In the meanwhile the people used home containers to store water drawn in the few hours that the supply was available. Gross faecal pollution of the supply occurred at the outlet valve and "clear" water chambers of the slow sand filters due to the lack of adequate drainage facilities for the filter overflow.

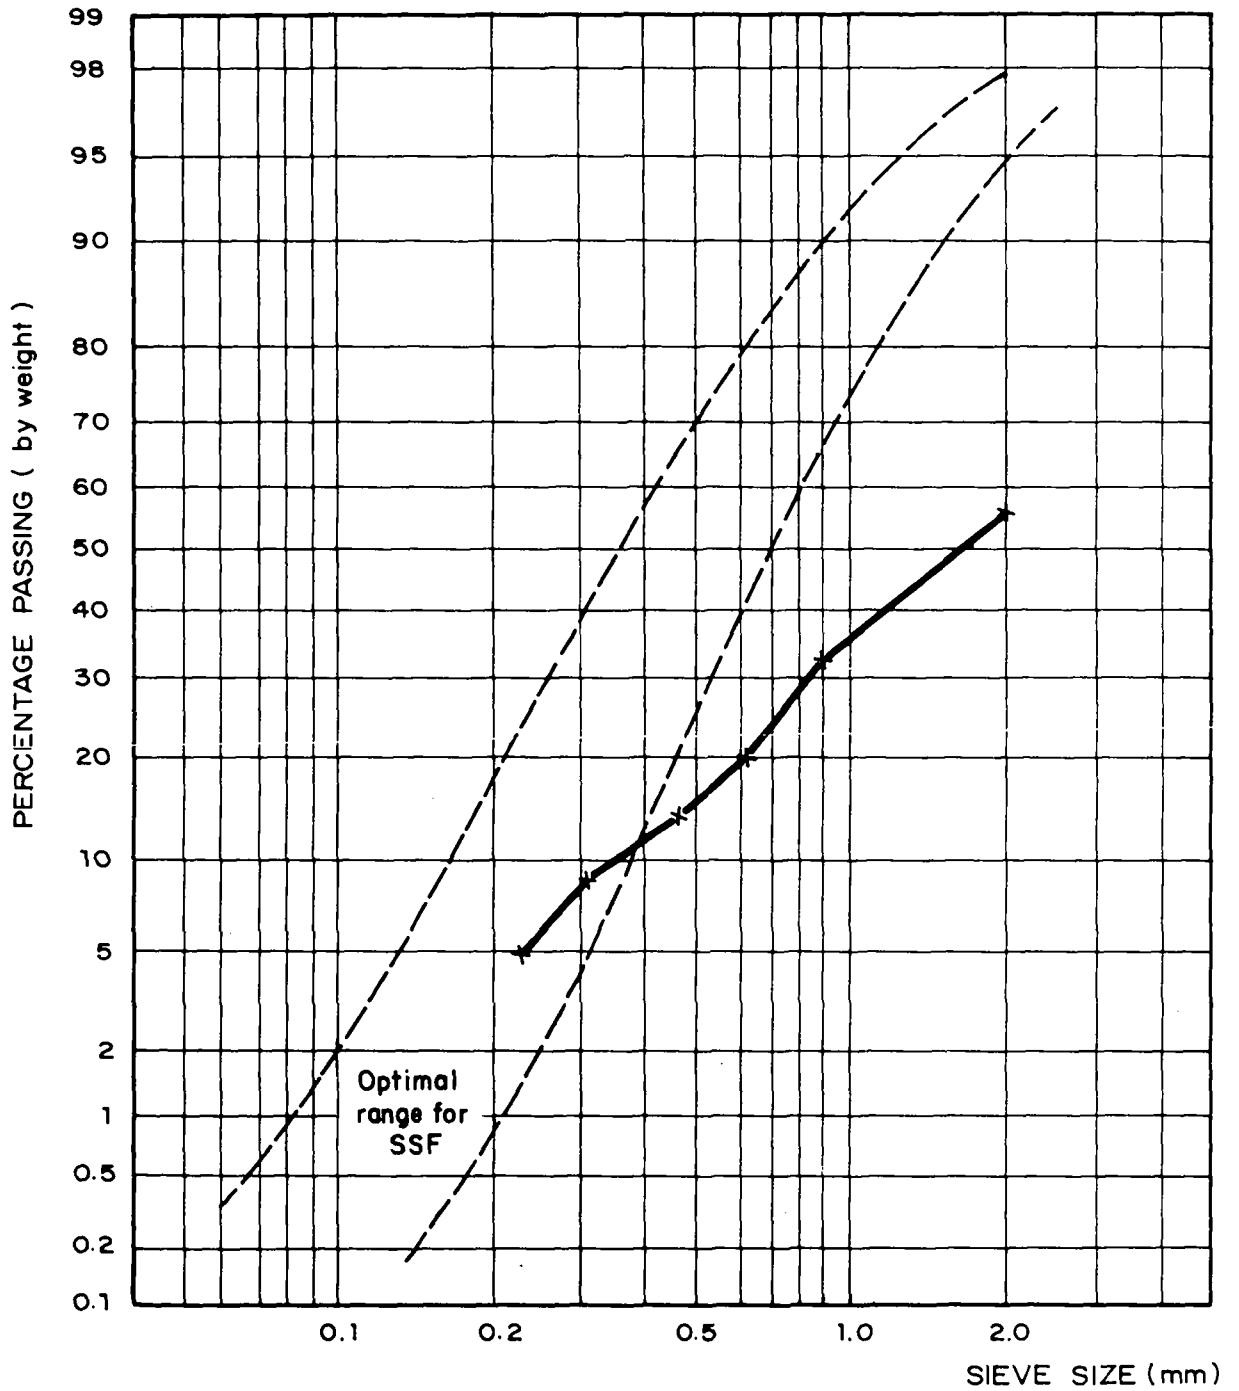
Figure 3. GRANULOMETRIC ANALYSIS OF SAND IN SSF PRIOR TO REHABILITATION OF TREATMENT PLANT IN COCHARCAS

EFFECTIVE SIZE = 0.32 mm
COEFFICIENT OF
UNIFORMITY = 7.8

A mixture of circumstances including faulty design, bad construction practice, disagreement over water use and inadequate operation and maintenance resulted in an insecure and intermittent service that represented a continual threat to the health of the community.
