Division of Building Research, CSIRO
Report 31

WATER STORAGE TANKS IN PAPUA NEW GUINEA
AND THE EFFECTS OF SEISMICITY

R.K.Hill and K.L.Biggs

1974

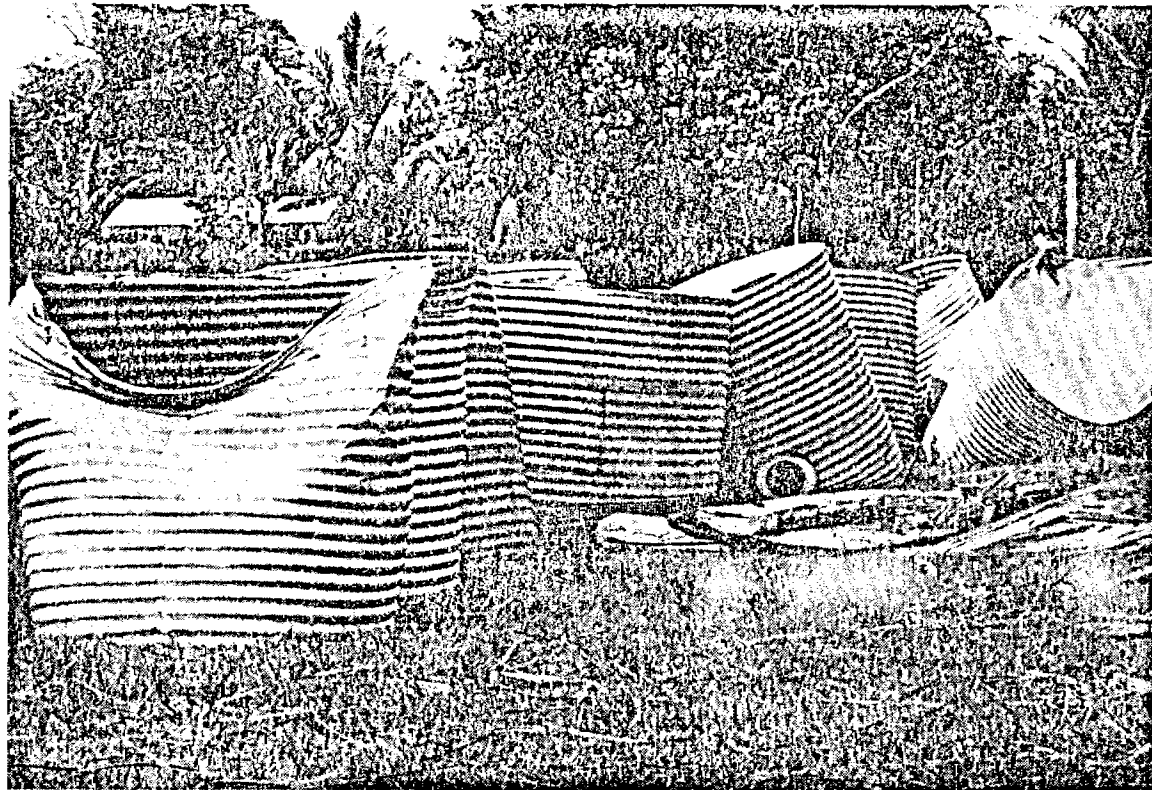
Fig.1 Aftermath of an earthquake: Some of the 12 water tanks ruined at the Bau Vocational School by the Madang Earthquake of November 1970

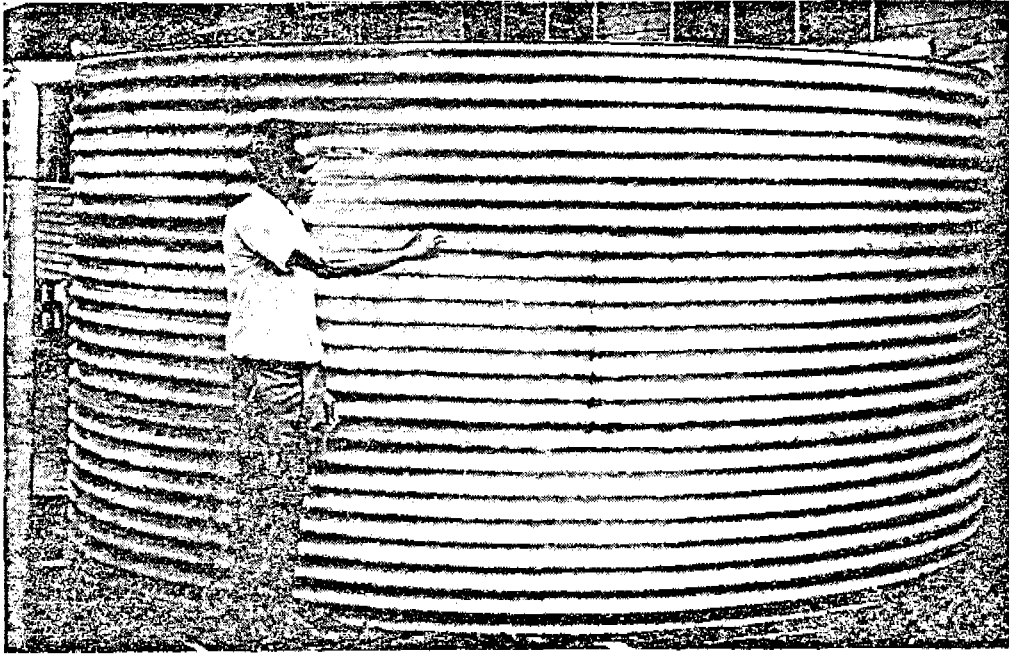
The standard material for tanks is a 0.56 mm (24 gauge) steel corrugated with a pitch of 76 mm (3 inch) and carrying a zinc coating of 550 g/m^2 (2.0 oz/sq.ft). Tanks are formed from curved sheets by rivetting and soldering the joints (Figure 3).

Fig.3 Corrugated galvanised iron tank showing rivet-and-solder join between sheets

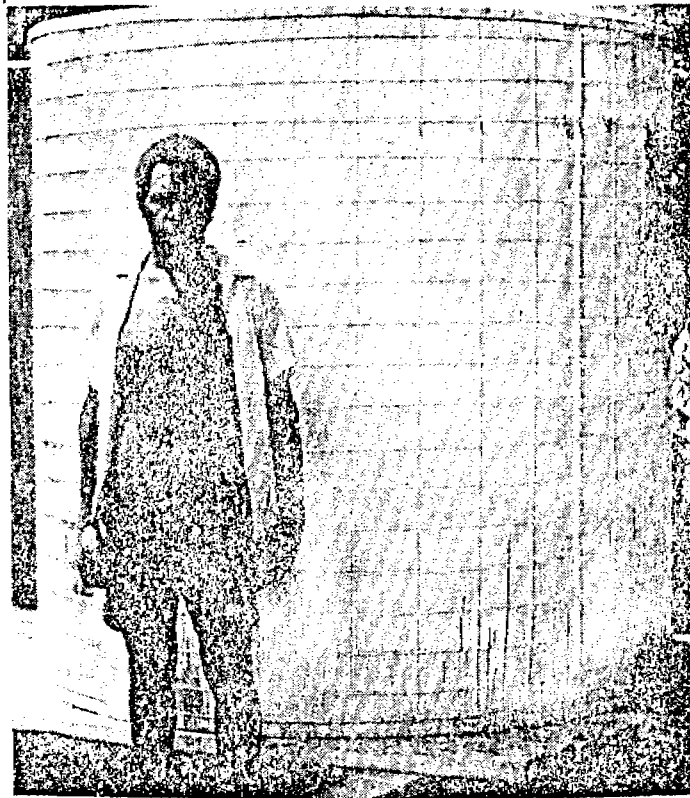
Certain difficulties have been encountered in the field with both types. The tank in kit form, although admirably suited to transport in PNG, requires a certain degree of skill and familiarity with resins in assembly (Fig. 5). The chief difficulty, however, has been with insufficient shelf-life of the resins supplies with the kit. The double-cone tank (Fig. 7), although readily assembled, has proved to be subject to damage in transport and in separating the cones nested for economies in handling. Furthermore both tanks while under test at the Building Research Station of PWD were found to be sufficiently translucent as to develop excessive algae growth within the tank to the point that the water was judged non-potable.

Fig.5 Polyester-glass fibre tank of the type supplied in kit form and cemented up in the field

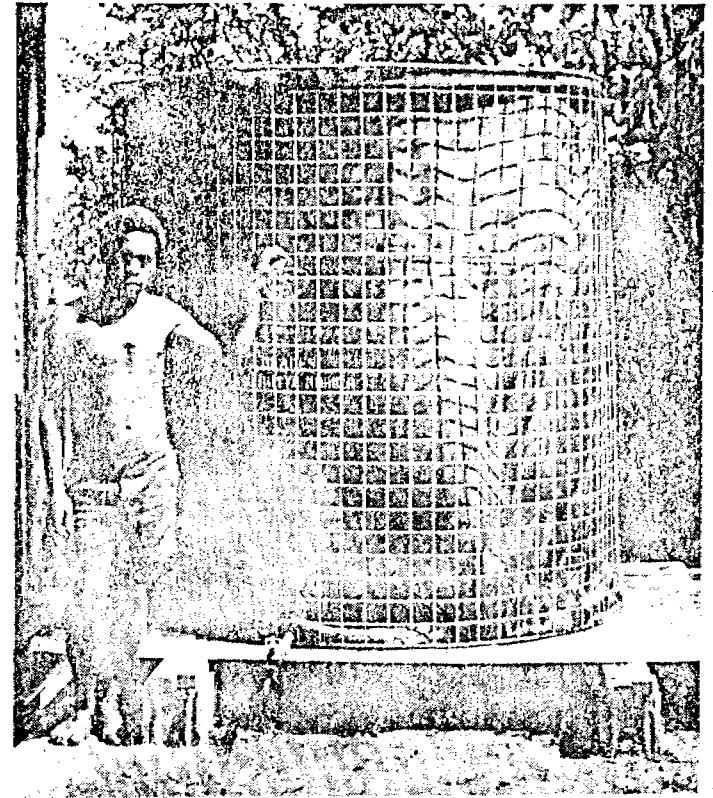
The Department of Public Works included a butyl rubber membrane tank (Fig. 6) in the 1971 tank comparison tests. Initially, water from the tank was considered to have a taste but this disappeared with use. The rubber walls of the tank apparently attract attention, and PWD had to repair a considerable number of punctures caused by pointed objects - including arrows.

Fig.6 Butyl rubber membrane tank showing method of support by galvanised steel mesh cage

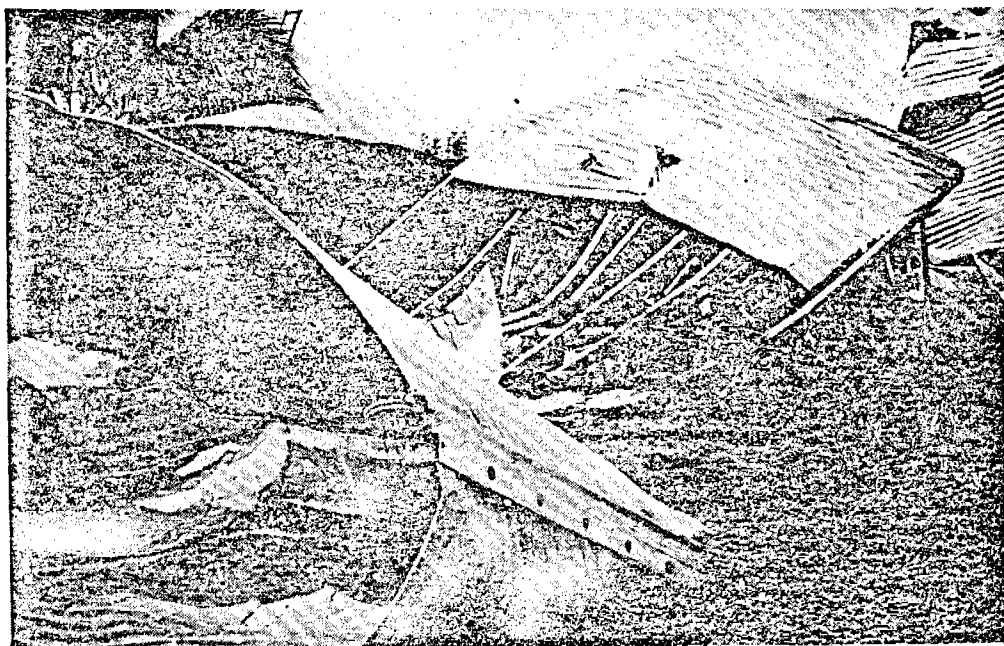
Fig.8 Tank damage at Malabunga High School (near Rabaul) following collapse of a steel tank stand during the North Solomon Sea Earthquakes of July 1971

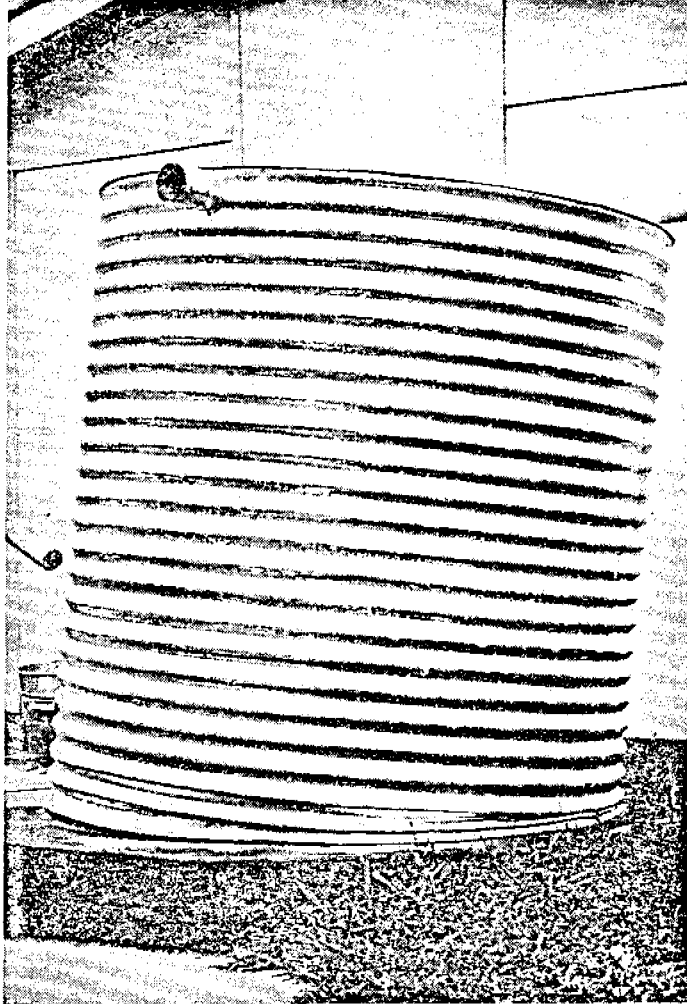
hole leakage caused by the jarring loose of protective corrosion products to the incontrovertible loss of the tank through being dashed to the ground with intermediate forms of damage comprising bursting of the soldered seams and the intriguing "concertina" collapse (Fig. 9).

The relative number of tanks in each category of damage is not known and little is on record regarding the damage sequence which may be expected during an earthquake although Denham (13) includes an account of the behaviour of water tanks at Brandi High School which, during the Wewak earthquakes of 1968, were observed to rock a foot off their stands before being concertinaed.

Fig.9 Failure of a CGI tank by collapse of the corrugations

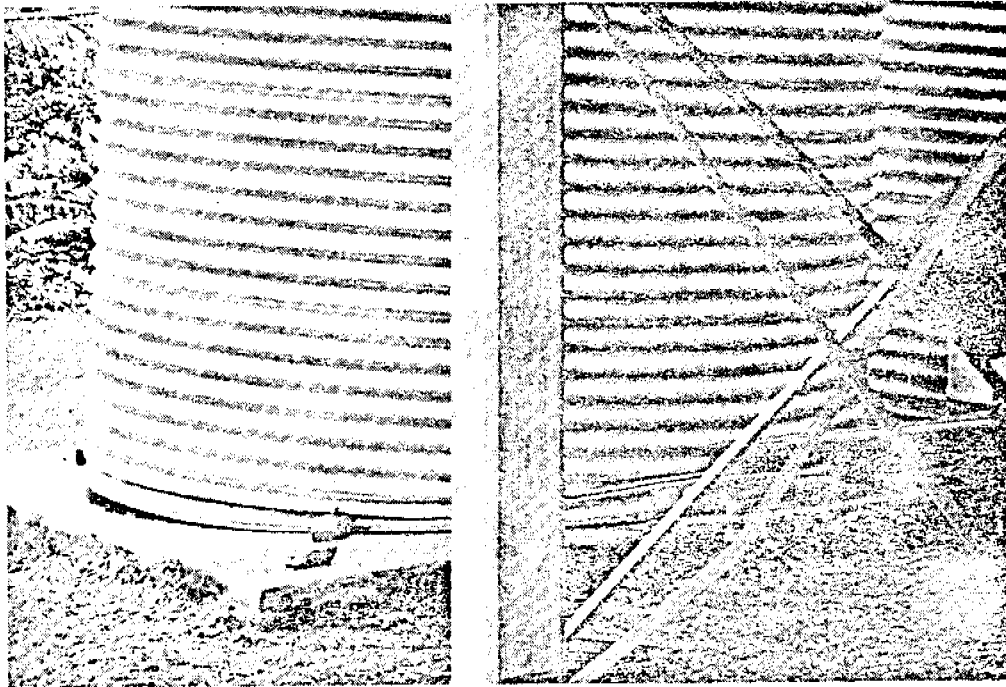
Various attempts have been made to restrain the tanks and prevent overturning. One method employed a number of wooden cleats, shaped to fit the bottom corrugation of the tank, which were bolted to the tank base or support (Fig. 12). During an earthquake, the metal of the tank tore at the cleats. Another technique used a wooden cross on the top of the tank pulled down to the base by four long bolts. In these cases, the tanks failed at the seams during an earthquake. The general impression emerges that the CGI shell has insufficient strength to control the water surges during an earthquake and that less damage may result if the tank is allowed to follow the movement of the water.

Fig.12 Example of domestic water tank fastened to the concrete base pad by wooden cleats. "Concertina" collapse of the corrugations is visible adjacent to the outlet pipe and tearing or splitting of the tank occurred on the opposite side where restrained by the cleats
