WATER SUPPLY REVIEW;

KINGDOM OF TONGA.

B. C. Waterhouse,  
New Zealand Geological Survey,

15 November 1984

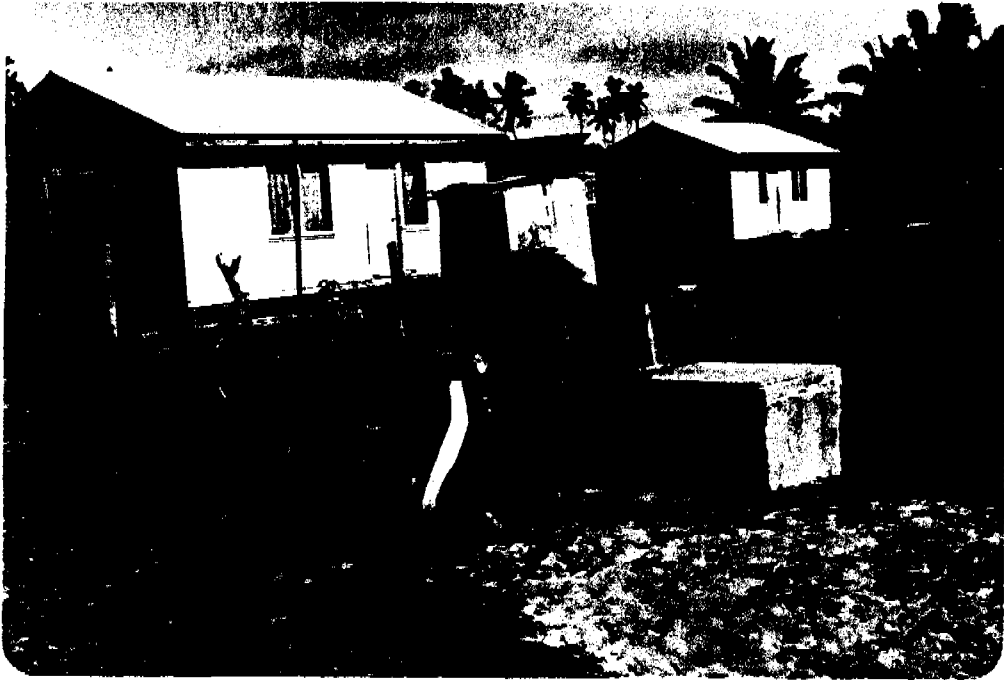
There are alarming incidences of potential health hazards on Lifuka, and perhaps elsewhere in Tonga, that need immediate attention as regards possible pollution of public wells by both human and animal activities. The pump test at Hihifo clearly indicated the permeable nature of the limestone both from the mathematical analysis, and visual observations of water cascading into the dewatered hole. At Tilulu College a public well (Fig. 7) from which water is pumped for community purposes is sited 11 m on the downstream side of a pit latrine. At Pangai in a sunken depression, the site of a collapsed traditional well now used as a rubbish dump, a pig and her litter were observed rooting around and defecating in the refuse. Each of these by itself is cause for concern; collectively they are even more so. The U.S. Public Health Service

Fig 7 Tilulu College public well and hand pump, Pangai, Lifuka Island, Ha'apai Group. The well is sited 11m from an open pit toilet at rear of house. Groundwater moves from left to right in open textured coral below a veneer of coral sand. A pump test (Fig 6) at Hihifo (Fig 5) indicates high transmissivity at  $50\text{m}^2/\text{d}$ . Lifuka is noted for its high incidence of typhoid.

states that there is no safe distance over which polluted water can travel in fractured or fissured rocks. The limestone base of the Tonga island is known to be highly permeable and as such it could transmit polluted water great distances.

- (2) Discourage use of 'traditional' wells because of their potential health hazard.
- (3) Continue to construct and encourage use of rain water tanks as a supplementary source in the event that the fresh water lens is satisfactory.

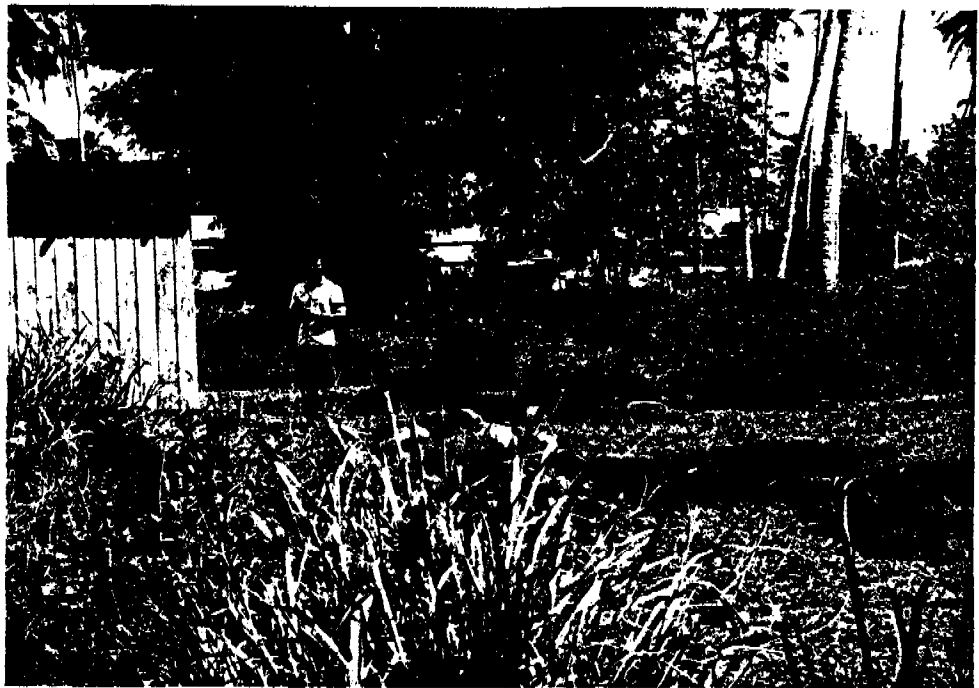
The only apparent barrier to surface water soaking vertically to the underlying aquifer seems to be the impermeable surface clay observed in Vaipua quarry. If this were punctured, as might happen during the digging of house foundations, post holes, septic tanks, or pit latrines,

Fig 10 Neiafu town water reserve area, Vava'u. Drillhole No 5 in left foreground with Tongan house and outbuildings beyond large tree. Main road and Mormon church in distance.

surface water would have immediate access to the aquifer. The coral limestone is known to be highly permeable because of the high yields obtained from drillholes both on Vava'u and Tongatapu, and from pump test results from Ha'apai, and as already pointed out, there is no safe distance over which polluted water can travel before becoming purified. A later visit revealed that the animals had been removed, and an assurance was given that the whole area was to be tidied up and that any surface activities were to be prohibited.

- (1) The same recommendations apply as for Tongatapu. Monitoring of the water levels in the Water Reserve, metering of the supply, and repairing leaks should be carried out immediately. The continued abstraction of water from Vava'u, without knowing what effect it is having on the lens could result in pumping salt water, as has happened on Lifuka.
- (2) No further development or pumping from the Water Reserve area should be undertaken until (1) is carried out and the results analysed.
- (3) The close proximity of the well field to built up areas increases the risks of pollution. It may be necessary to start to look now for alternative areas in which to establish a future well field.

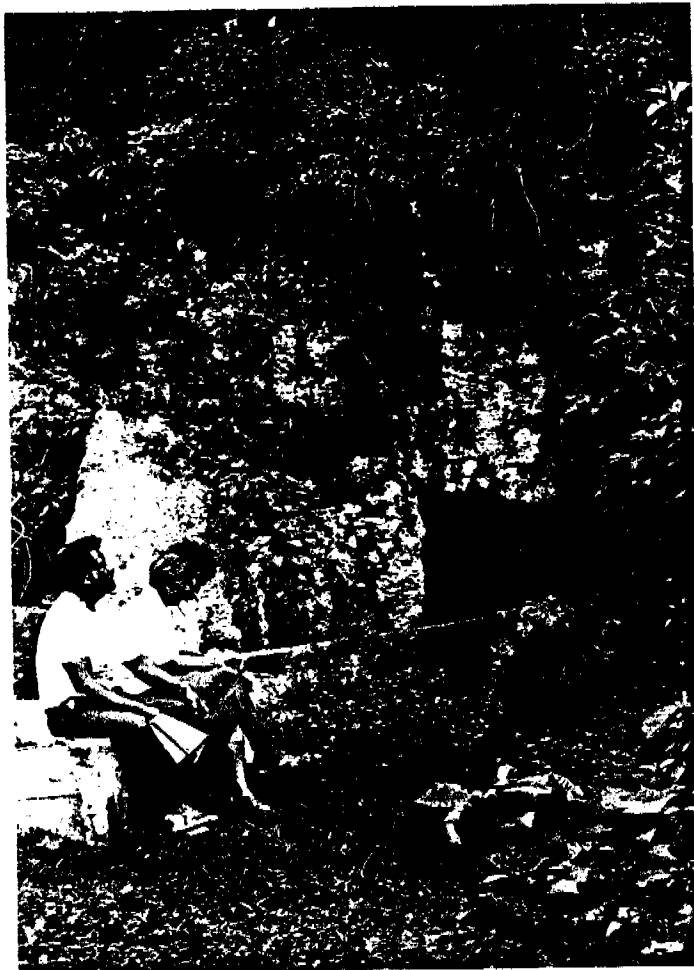
Fig 13 Kahana Spring, source of water for Houma village,

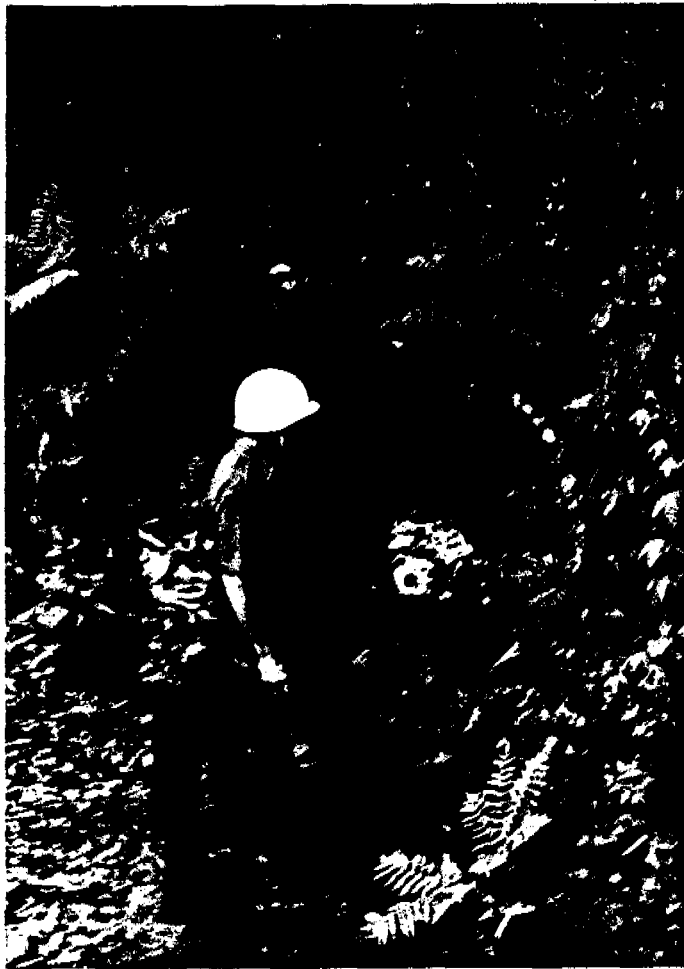
The Vaitaki intake (Fig. 14) was not visible because it is sited in a cave the entrance to which is blocked off. A 150 mm (6 in.) pipeline leading from the entrance is covered by rocks blasted from a limestone face above, before entering another cave and emerging further downstream. It was not known when the intake had been last inspected nor what effect the falling limestone rock had had on the pipeline, factors which should be cause for concern. Magno (1982) reported that debris, muds, and silts were built up at the Vaitaki intake, and that holes and openings above the Vaitaki allowed surface runoff carrying silt and debris to enter.

Fig 14 Vaitake intake,  
in cave the entrance of  
which is blocked off by  
coral blocks.

Such build up of material in the cave would be a continuing process and would not be flushed out because the entrance is now blocked.

- (3) In terms of supply and health hazards 'Eua is number 1 priority in the Kingdom. An alternative to the present system is necessary but it may take 12 months or so to organise and implement. Clean out dirty pipes and intakes as remedial measure only until a better supply is found.

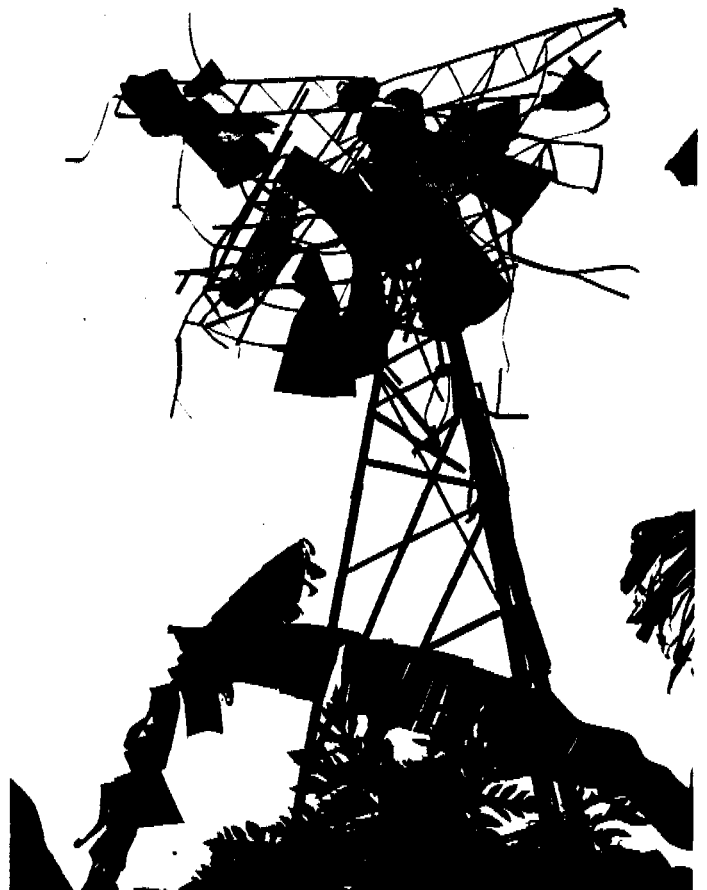
Fig 15 Windmill damaged by  
hurricane Isaac, 1982.

Ultimately the skills could be passed on and even relatively difficult jobs such as re-erecting windmills and other facilities damaged by earthquakes or hurricanes could be attempted, rather than do nothing as is apparent from the windmill (Fig. 15) damaged by hurricane Isaac in 1982.
