Rainwater Harvesting for Domestic Water Supply in Kisii, Kenya

RAINWATER HARVESTING FOR DOMESTIC WATER SUPPLY

IN KISII, KENYA

Thesis submitted as partial fulfillment for the requirements of Master of Science Degree in Engineering to Tampere University of Technology, Department of Civil Engineering.

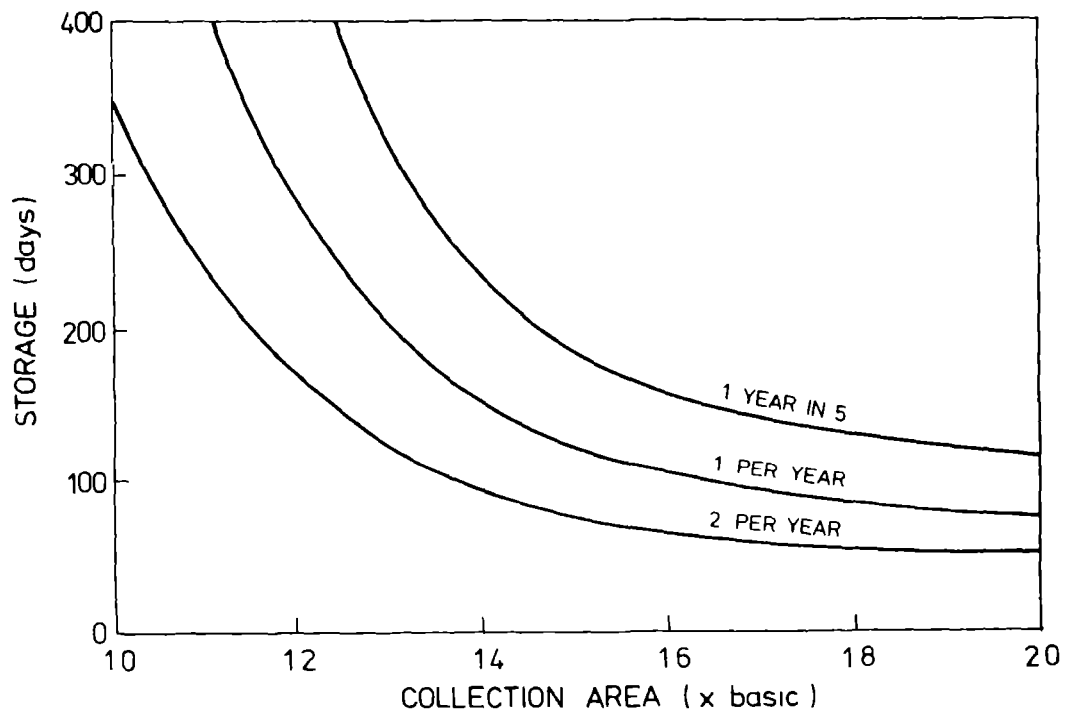
Figure 2: Relationship between collection area and storage for Coff's Harbour for a given demand for various probabilities of "failure" (Perrens S.J., 1982).

A relationship between catchment area and storage for a given demand situation can be established for a given area. Nomographs can also be drawn incorporating various probabilities of failure of supplies. This storage to area relationship is very useful and such an analysis can account for big savings in design costs especially when funds are scarce. Figure 2, below has been reproduced for a rainwater station in New South Wales, Australia. It is intended that similar nomographs be prepared for the study area.

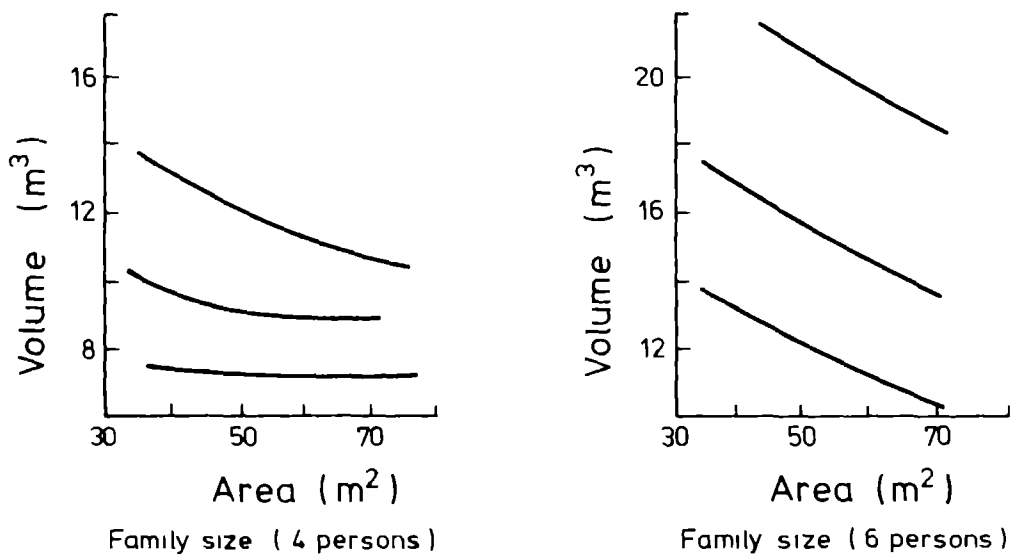
Figure 3: Cistern Volume nomographs based on roof area and family size (Doelhomid, 1982)

Nomographs also relating cistern volumes, roof area and family size can be drawn, for a given mean annual rainfall. Such nomographs have the shapes shown in Figure 3 drawn for an area in Indonesia.

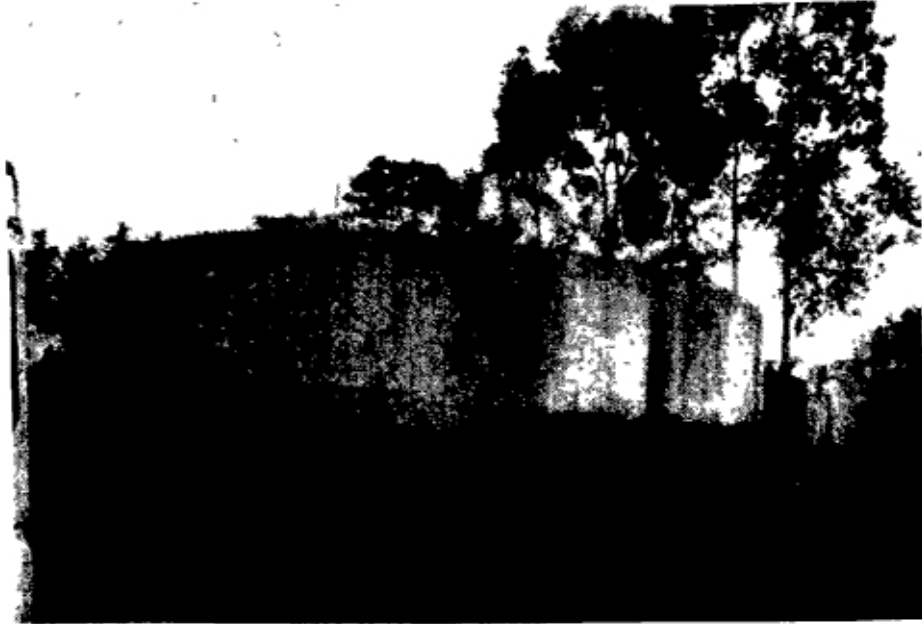
Fig. 10: Matongo Main Rainwater Storage Reservoir

concrete tanks, one 20m^3 concrete tank, another 15m^3 tank; six 5m^3 concrete tanks and ten corrugated sheet iron tanks of capacity 5m^3 each. The total storage capacity of this centre is 1065m^3 . The per capita consumption is very high, so that the demand is always higher than the supply. In fact it was reported that since the big storage tank was constructed it had never filled up with water. However, if the mean annual rainfall for the area is taken as 1,500 mm, they should be able to collect a total volume of about 6000m^3 from their roofs. This water cannot meet their requirements at a consumption rate of 20 l/c/day. The needs for the supplementary sources - well water is justified and they have plans to use the river Sondu water in future. As it is, they require more storage volume facilities to collect all the water and the ^{system} / should be checked for leaks.

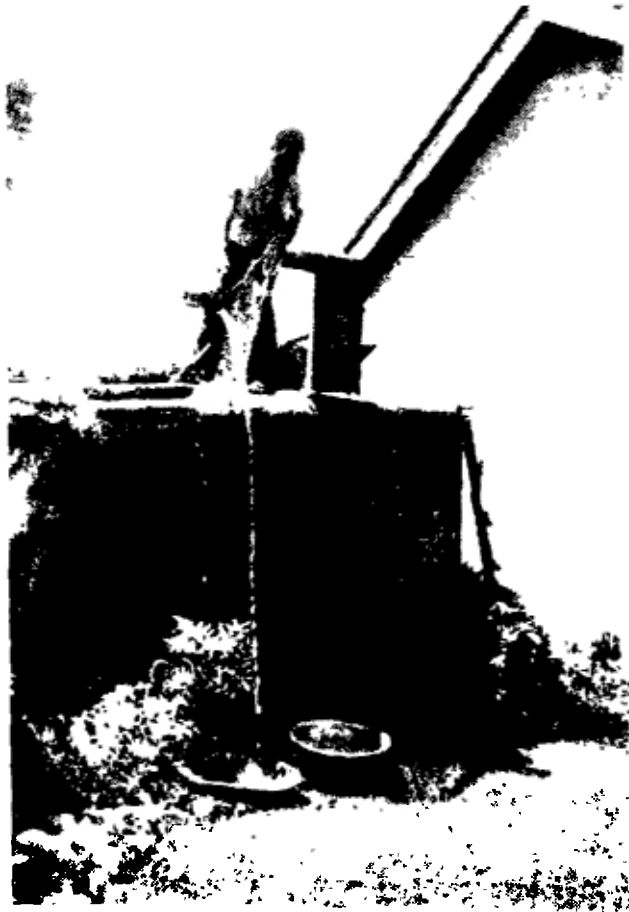
Fig. 13. Water withdrawal from Mr. Osoro's water tank.

Such withdrawal practices should be discouraged as they contaminate the water. In this case the tap has been blocked due to bad design. The tank has never been cleaned for 10 years. A climbing ladder can be seen and the area around the tank is covered with shrubs.

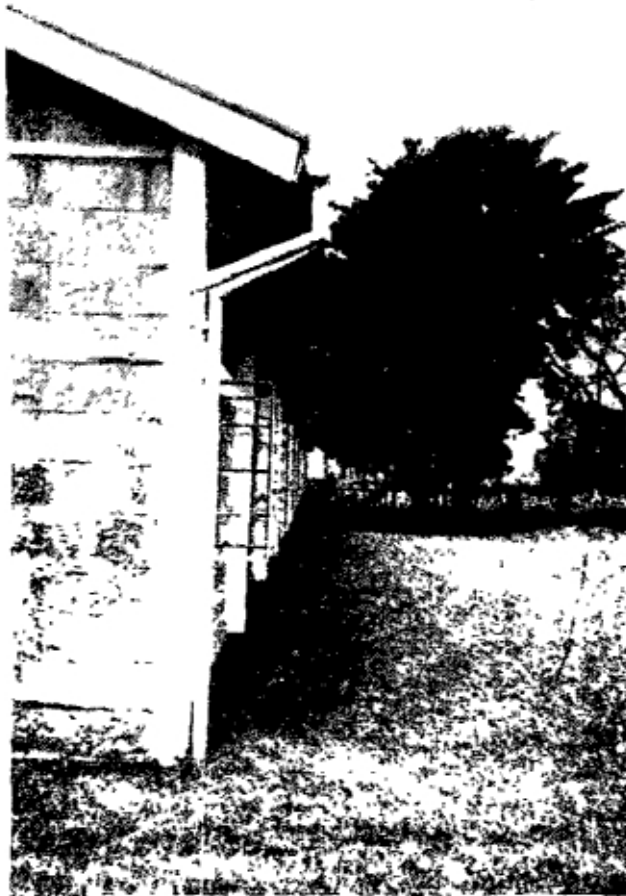
Fig. 14. Downpipes at St. Mary's School Mosoch

The figure shows down pipes from one of the classrooms taking water to an underground storage from which it is pumped to an elevated tank before use.

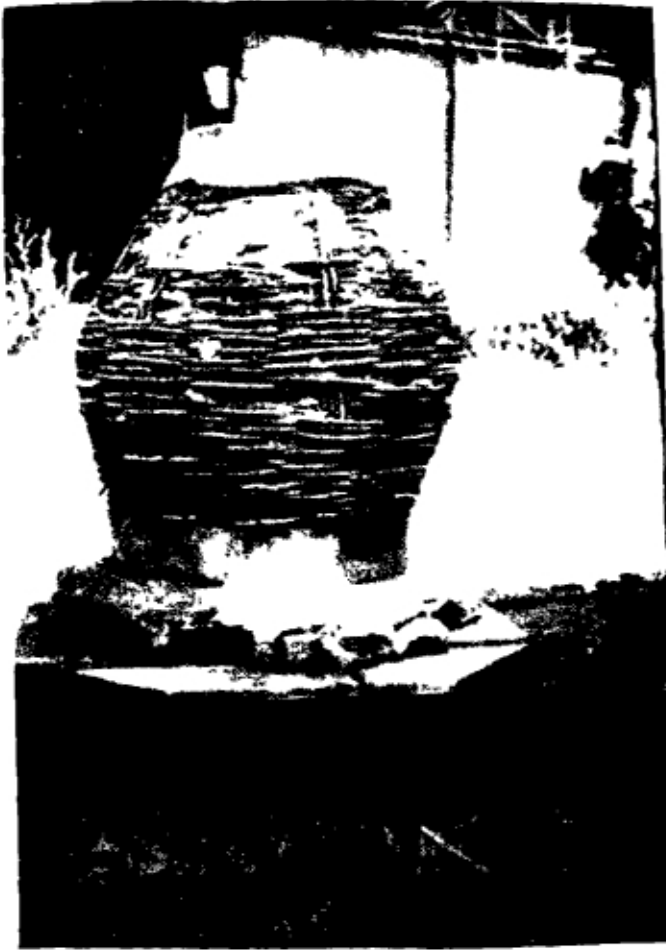
Fig. 18: Granary Basket Tank

Figure 18 shows one form of a granary basket tank as used at Matongo Mission.

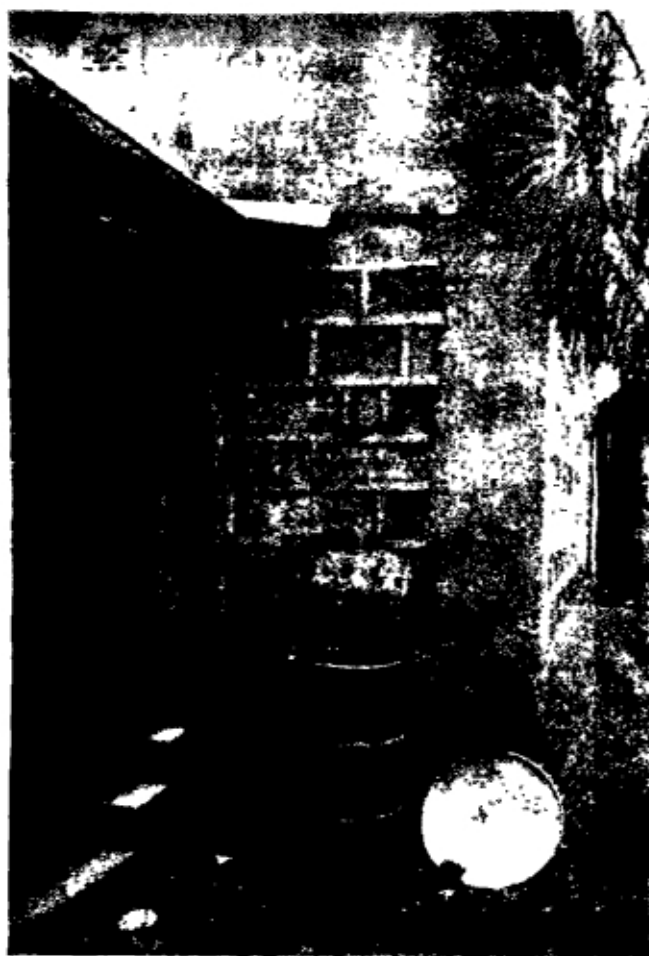
Fig. 19: Used Oil-drum Container

Many individuals in the study area have good roof catchments but cannot afford to purchase or construct permanent storage facilities. It is common to see rainwater in their homes being collected in semi-permanent containers mainly used oil drums. These containers themselves do not look clean, but are used for lack of better alternatives. Figure 19 shows one such form of rainwater collection.

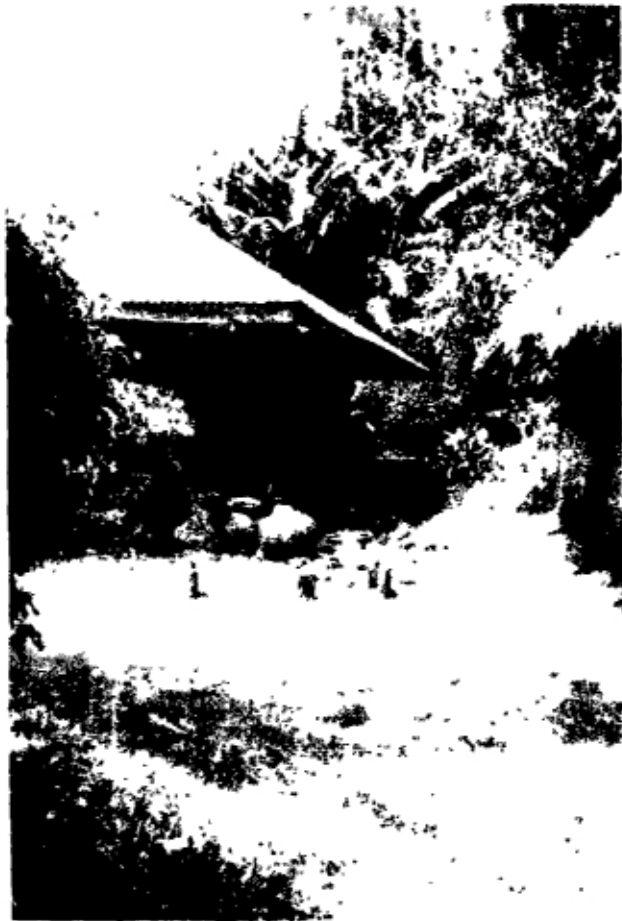
Fig. 20: An Assortment of Portable Containers

The figure shows all sorts of portable containers, standing where
a galvanized ^{iron} / sheet tank used to sit.
