Village Handpump Technology

Research and Evaluation in Asia

Editors: Donald Sharp and Michael Graham

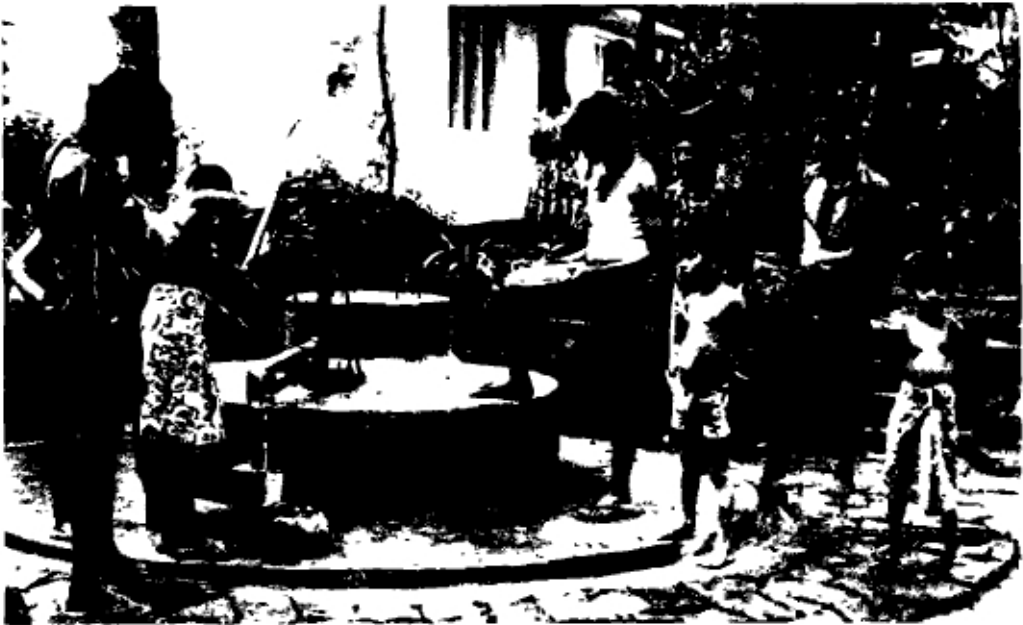
Fig. 1. View of well showing drainage channel to remove spilled water and stone layer to assist drainage

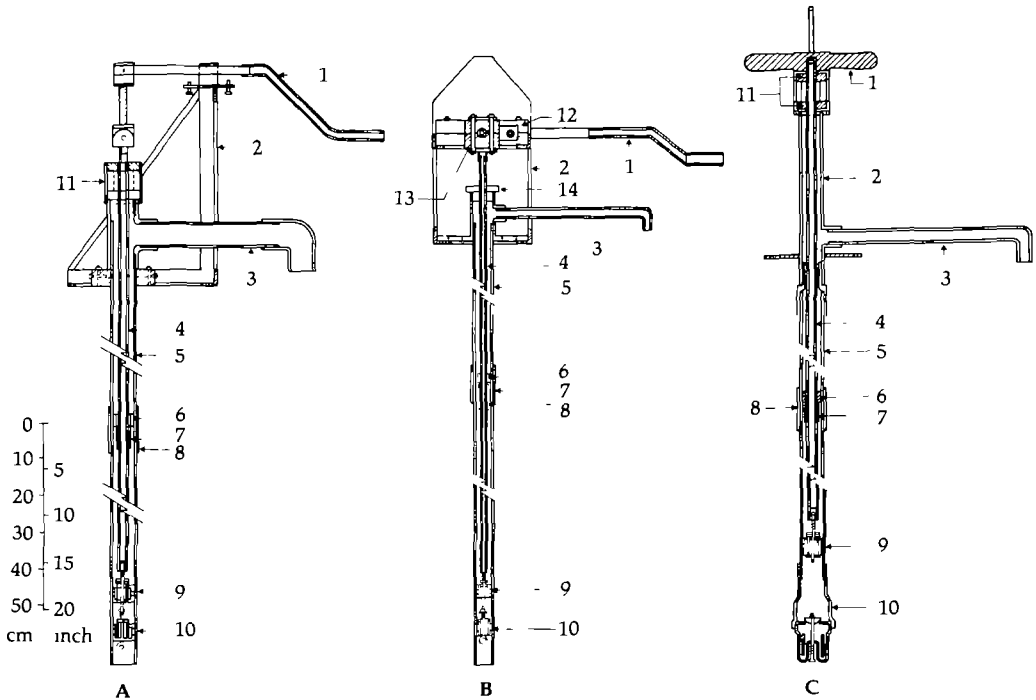
Fig. 4. (A) L1 pump, (B) L3 pump, and (C) V1 pump (1) handle, (2) frame, (3) spout, (4) piston rod, (5) riser pipe, (6) piston rod guide, (7) piston rod joint, (8) riser pipe joint, (9) piston, (10) check valve, (11) wooden bearing and counter box (L1 and V1), (12) main bearing (L3), (13) big-end bearing (L3), and (14) counter base (L3)

For field-testing, a total of six of these pumps were installed. Four at Talawa and one each at Ginimallagaha and at the Sarvodaya Main Centre. These pumps were used to replace the L2 pumps that had been installed originally in these wells. The frame of the L2 was made out of concrete and used a wooden handle. The original L3 pumps also used a handle that pivoted on a bearing fixed in a concrete pedestal. Although this arrangement proved more successful than the L2 pump, it also had to be changed because of excessive, and rapid, wear of the wood at the pivot point. This meant that the handle could be lowered to the point where it would make contact with the outlet spout, resulting in a constant banging by the handle during the operation of the pump that resulted in the joint between the pump head and the spout cracking. This problem was remedied by designing a new handle that prevented overlowering and at the same time made the pump easier to operate (Fig. 4).

components of these pumps (see Table 1 and Fig. 4) worked well and did not require modification. Originally, a 7.5-cm cylinder was used for the riser pipe and a 5-cm pipe was used for the above-ground portion of the pipe. However, this meant that the 7.5-cm piston could not be removed for repairs without cutting the cylinder. To make repairs easier and to save time and labour, a 5-cm piston is now used along with a 5-cm pipe for the entire length of the riser pipe and cylinder.

Nine of the V1 pumps (Fig. 4) have been installed: four at Akurala; four at Yatiyana, and one at Hingurudugoda. The wells at these sites are 3–4 m deep. The above-ground components of this pump were modified based on our experience, the results of the field testing, and the suggestions of the users. We found that the original metal handle made this pump difficult to operate, therefore we switched to a wooden handle. We also discovered that the piston could be pulled out of

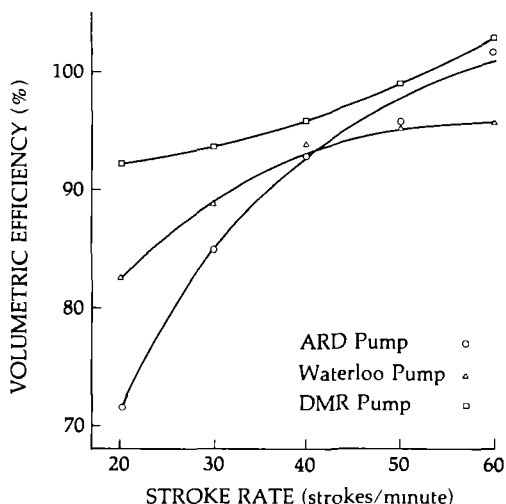
Fig. 4. Comparison of volumetric efficiencies for different pumps having 6-inch (15-cm) stroke length

The performance of DMR and ARD handpumps under laboratory conditions was also plotted. At low speeds of piston movement, the volumetric efficiency of ARD handpumps was lower than that of DMR handpumps. At higher speeds of piston movement, however, the volumetric efficiency of ARD handpumps improved significantly. At very high piston speeds, the volumetric efficiency of the DMR handpumps exceeded 100%. This can be explained by the fact that, when the pump is operated at very high speed, extra water from the riser pipe is pumped up.

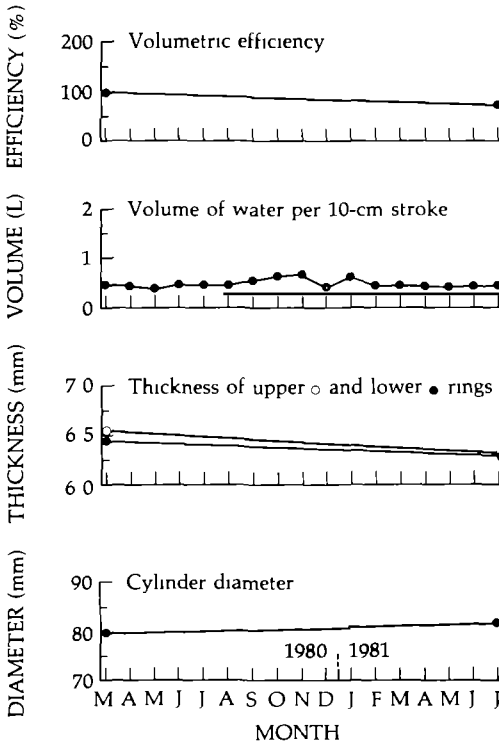
Fig. 9. Performance of 3-inch (7.5-cm) cylinder handpump in Saraburi and Lopburi regions

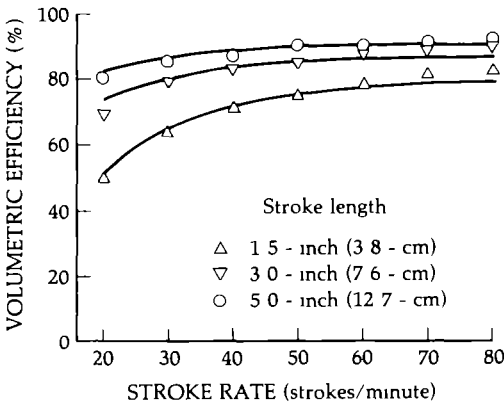
Fig. 3. Variation of volumetric efficiency with speed of stroke application for three stroke lengths (theoretical lines and experimental data points) valve gap, 0.113 inch (2.87 mm), valve weight, 0.029 lb(force) (13.15 g), orifice/piston ratio, 16.4%, and water head, 230 inches (3.66 m).

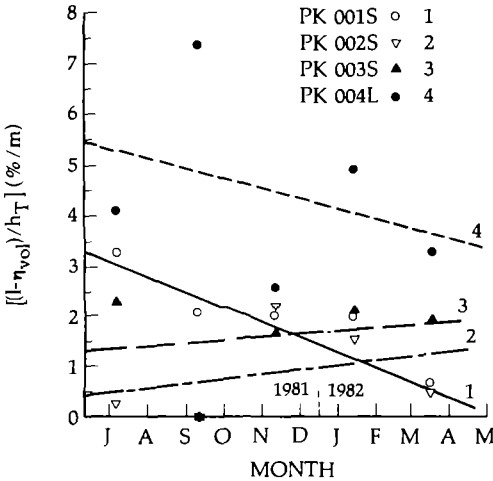
Fig. 9. Variation of $(1 - \eta_{vol})/h_T$ with calendar time for four pumps

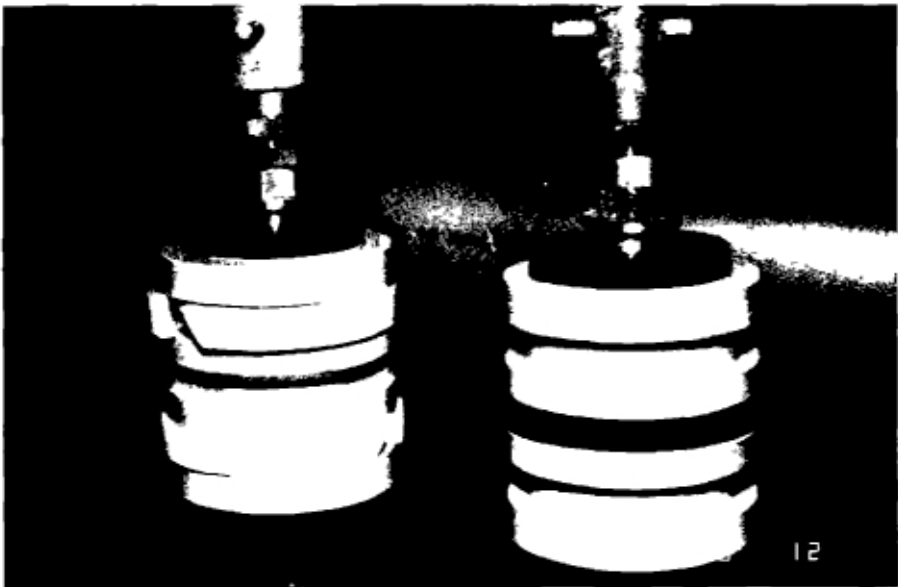
The Waterloo piston (left) and foot valve (right) are moulded from solid PVC. Except for the piston rings and the rubber seal on the foot valve, they are interchangeable.
