**FIELD EVALUATION OF
STEEL FABRICATED HANDPUMPS FOR
THE USAID/DOMINICAN REPUBLIC
HEALTH SECTOR II PROJECT**

WASH FIELD REPORT NO. 139

FEBRUARY 1985

Prepared for:
USAID Mission to the Dominican Republic
Request Memorandum No. 106

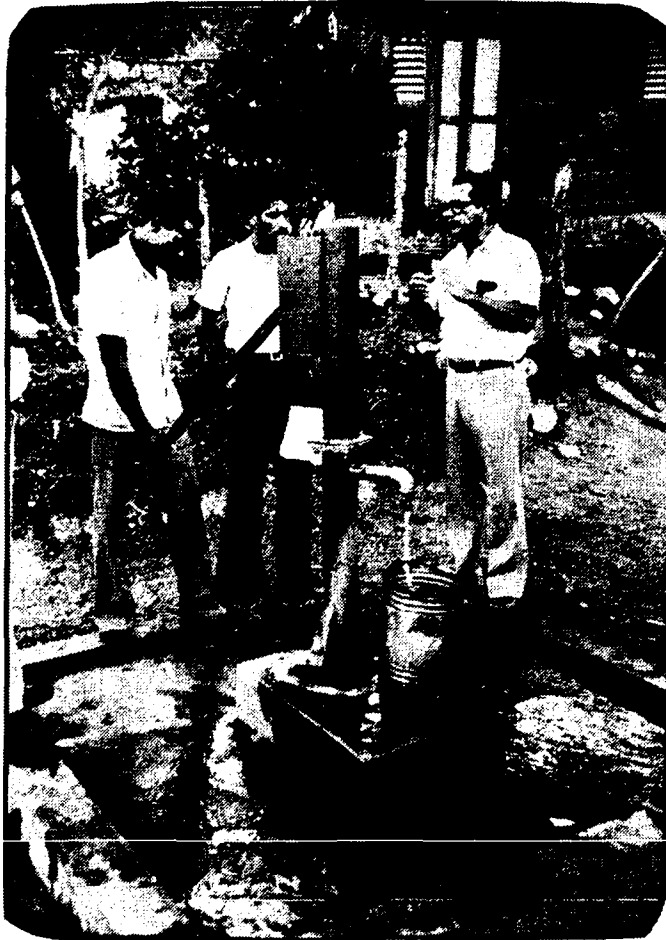
Illustration 1. Locally manufactured "Steel" fabricated handpump with ball bearing handle support system being field tested in the Dominican Republic.

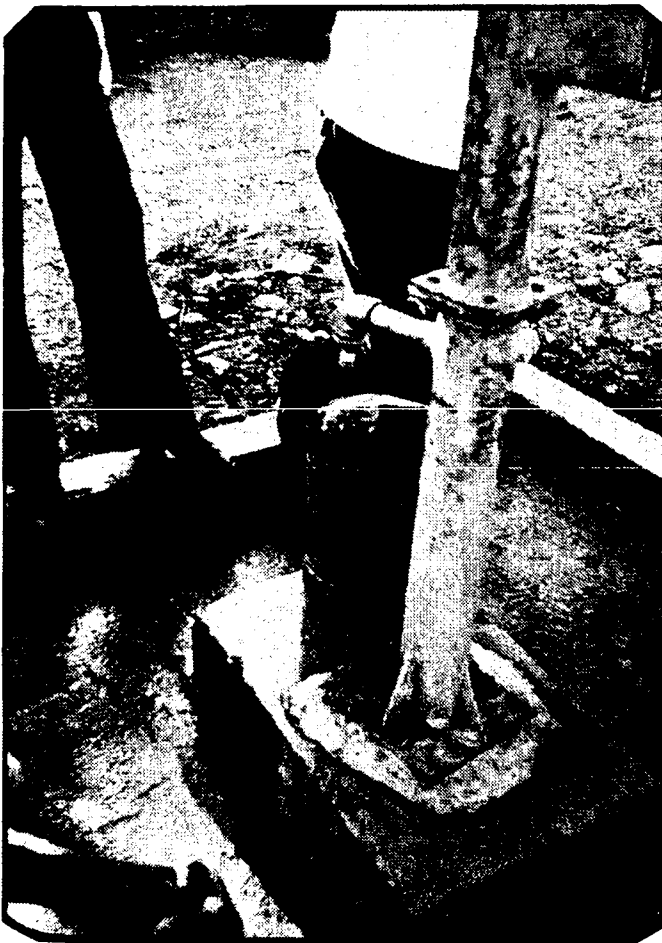
All of the handpumps observed in the field revealed a common design problem that does not allow the base to make a positive, unbreakable sanitary seal. The current design depends on the bond between the base plate and the top of the platform. (The top of the well casing is level with the top of the platform.) Cracks in the grout used to level the base were observed to allow small amounts of water to enter the water. Over the years, this condition can be expected to get worse (see Illustrations 8 and 9).

Illustration 8. Note grout used to level the platform to accommodate the flat plate of the base. Cracks in this grout allow water to enter the well as the casing is flush with the platform.

The pedestals were found to be firm in all cases and to be of a high-quality welded fabrication. In all cases, however, there was evidence of surface water leaking into the bore hole. This situation raises grave doubt that the present system would ensure hygienic conditions. Grouted bolts in a cement platform also present a problem over the long term. If the bolts are rusted or threads stripped, replacement is difficult as the concrete platform has to be broken out to allow replacement of a new bolt. If the present method is continued, wells will be open to pollution, and in many cases the pedestals will rust out within three or four years.

To ensure a hygienic seal, the present base should be modified to have a separate mounting plate that fits over the casing pipe. This plate becomes part of the platform by being grouted into the concrete around the casing (see Figure 5). The unit must be completely galvanized, and overspecified in fabrication, as it will remain in place for the life of the installation (20 to 30 years). The pump pedestal is then mounted on this fixed plate by means of standard bolts, thereby allowing easy replacement.

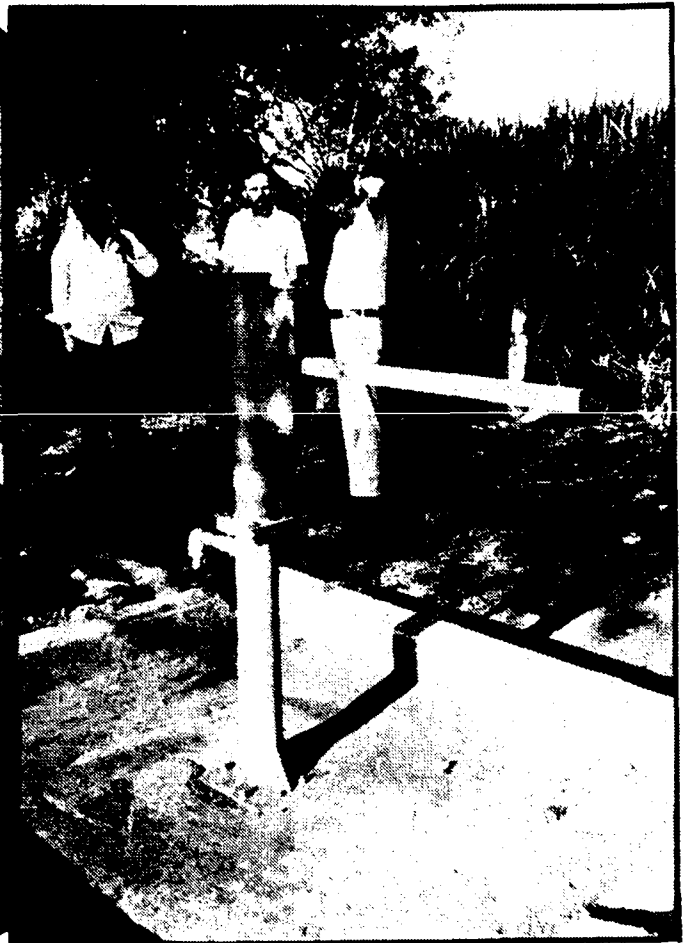
Illustration 9. Note that platform grouting will cause water to pond at pump base and raise the potential of infiltration into the well through cracks in the grout.

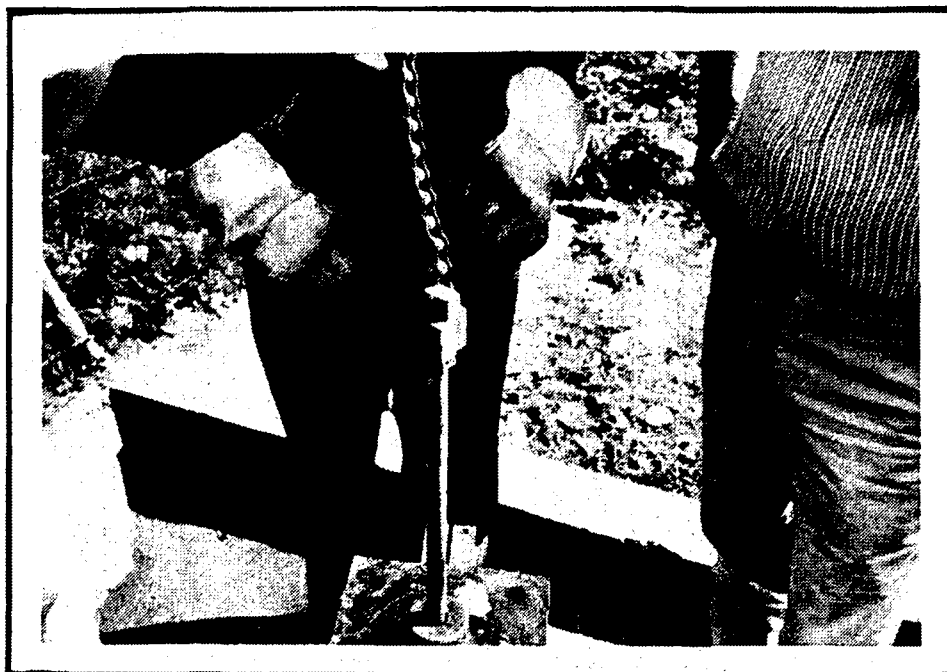
After observing the 15 field sites, it was noted that there had been three failures that occasioned replacement of the design chain (see Illustration 12). On studying these failures, it was noted that a heavier chain was called for. This change was first made at the deep well at Hania (160 ft.). It was, however, beginning to show up in another deep well (40 to 50 feet) after 9 to 11 months of operation. A heavier chain was installed at Hania and is currently working well.

Illustration 12. Note the broken link at the modified drop rod connection. This modification allows the use of a chain link connector of the drop rod.

The roller chain selected by the Georgia Institute of Technology (motor cycle No. 428 or Industrial RC40) appears to be too light. In addition, the scheme to connect the chain to the quadrant has been modified to use standard chain connecting links. The light chain and the modified system seem reasonably satisfactory at shallow SWL depths (that is, 7 feet to 20 feet). At depths greater than 30 feet, however, it is expected that early failure could be common. The one pump set at 160 feet (Hania) required a heavier duty chain to be fitted after constant failure of the original.

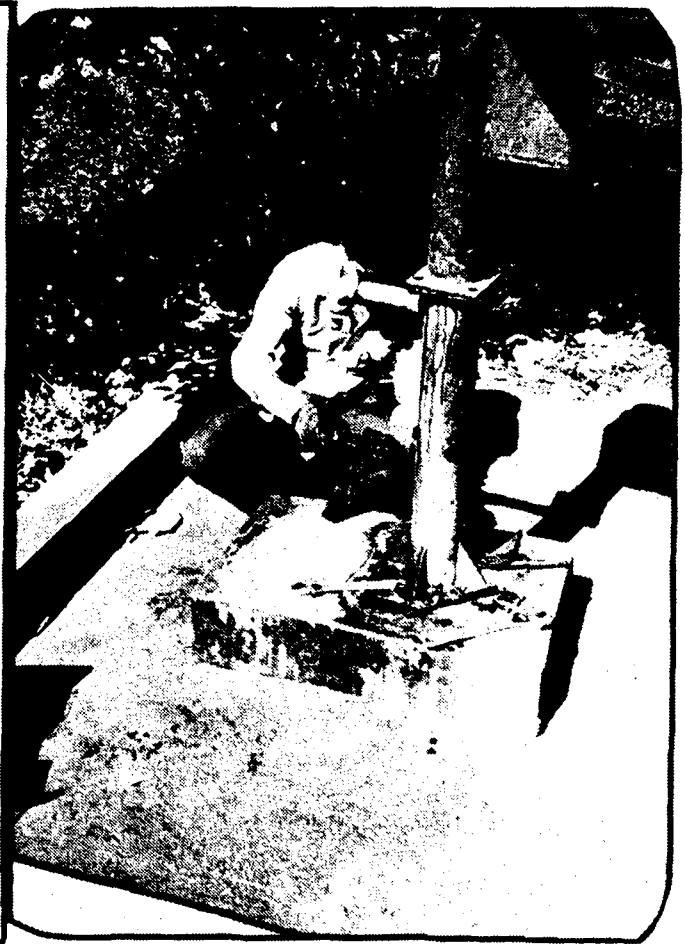
Illustration 15 shows the diversity of tools that the field crews are currently using during pump repair visits. WASH feels that the numerous tools should be standardized to a few simple key ones. Such standardization would help to reduce the broken bolts and the tendency of field personnel to use pliers and lockgrips which tend to destroy bolts quickly.

Illustration 15. Field maintenance crews have few tools. Thus, they tend to make extensive use of lockgrips and pliers. As a result, many bolts have been either chewed or stripped.

It is recommended that a front cover be provided to allow easy access to the chain, not only for greasing, but also for inspection and simple replacement. Standardized simple tools must be considered, similar to those used with the India MK II System, that is, crank-socket wrenches to tighten flange bolts, and the chain anchor bolt (see Appendix B, Installation).
