EMERGENCY TECHNICAL ASSISTANCE TO BOTSWANA FOR RURAL WATER SUPPLY

WASH FIELD REPORT NO. 269

EMERGENCY TECHNICAL ASSISTANCE
TO BOTSWANA FOR
RURAL WATER SUPPLY

by
Michael Webster
Fred van der Geest
Philip Roark

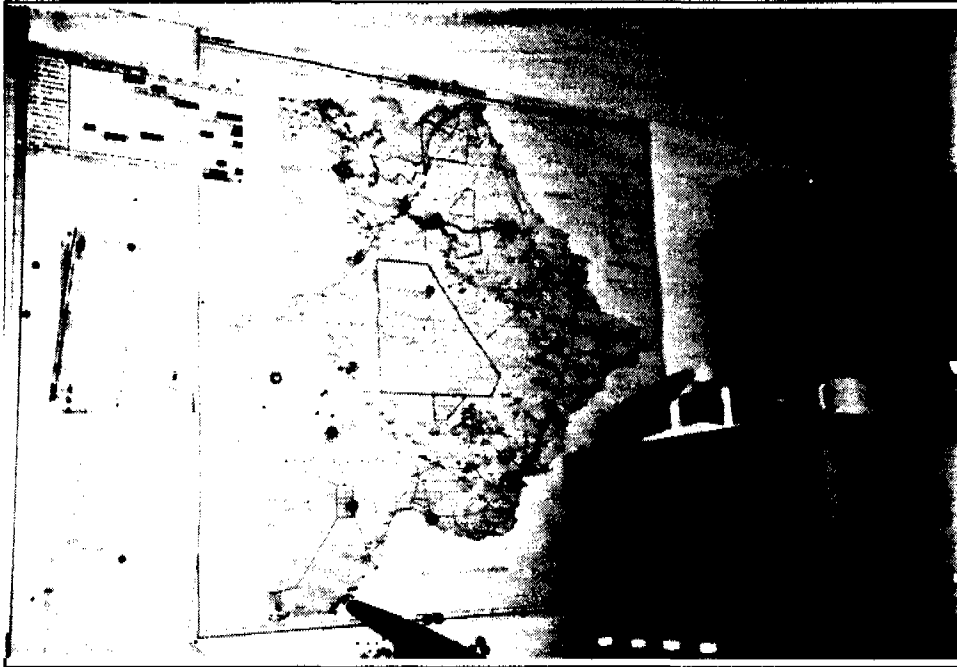
1. Circles on map of Botswana showing widespread locations of drilling sites. Drought affected villages as much as 1000 kms apart.

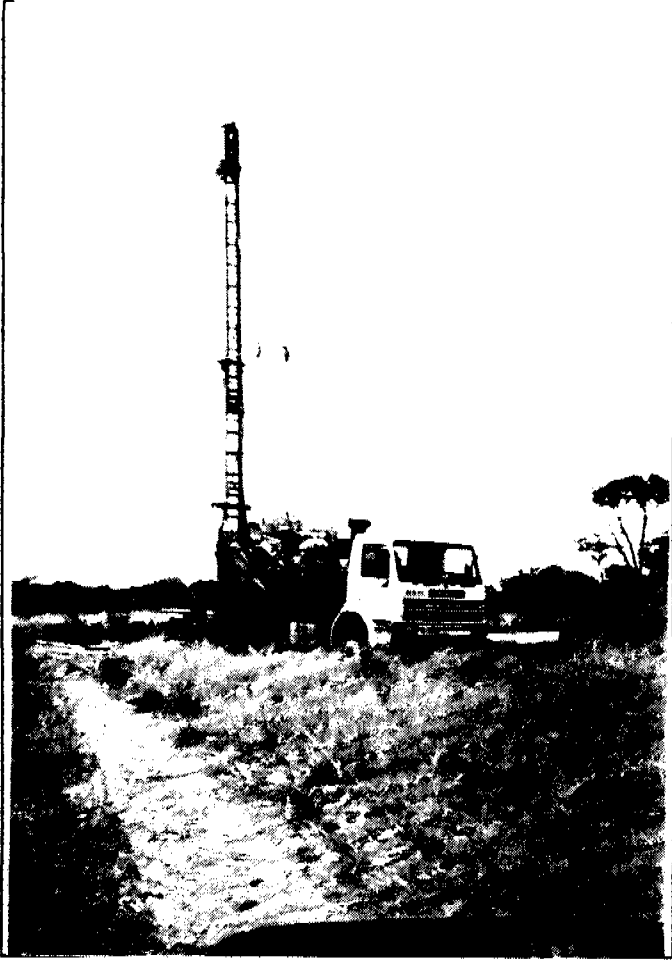
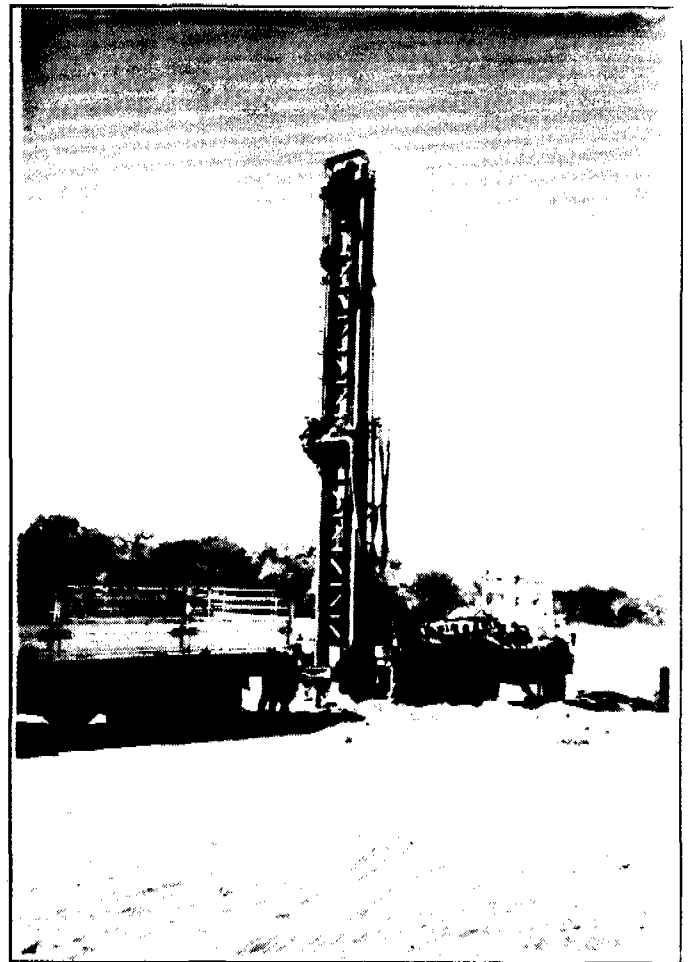
Photos 3 & 4.

Drilling is conducted under varying conditions. Sand is frequently a problem in the north and western parts of the country.

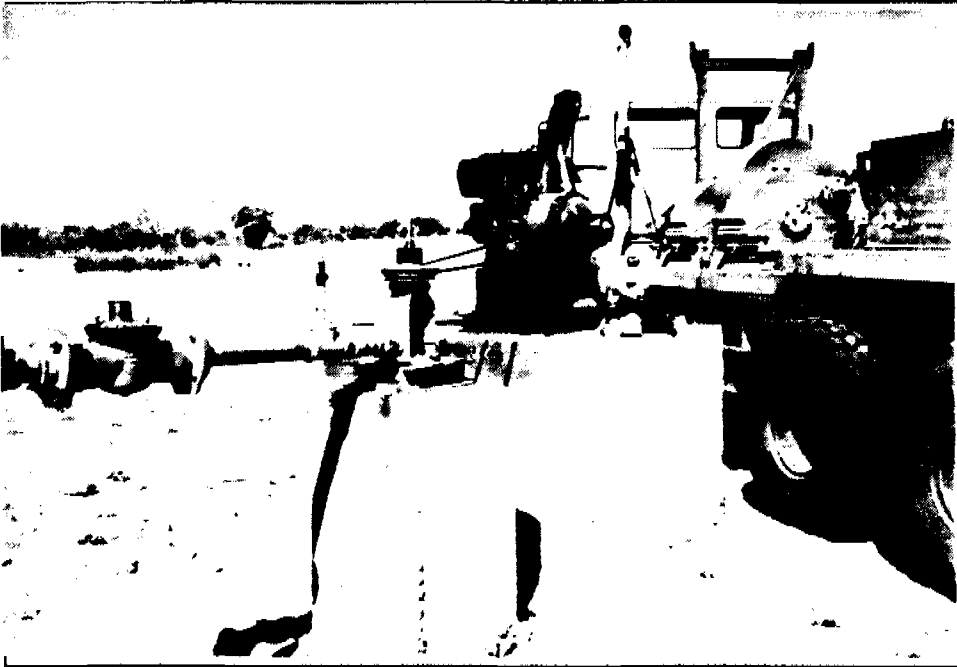
5. Well equipped with pump. Water distribution system is under construction.
