Lucy Lytton
MSc, CGeol, FGS, CSci

is senior hydrogeologist at
Veolia Water

Deep impact: why post-tsunami wells need a measured approach

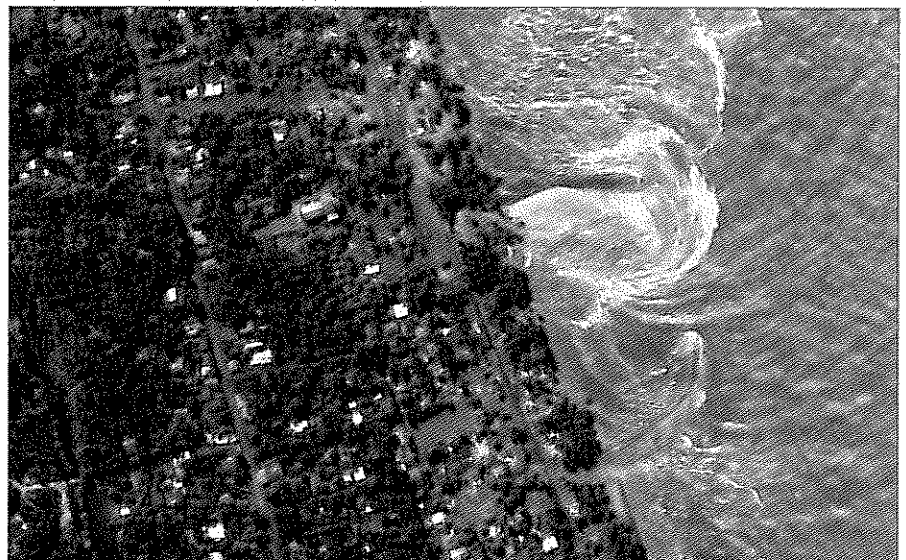
Fig. 1. NASA satellite image of tsunami waves inundating the coast of Sri Lanka on 26 December 2004 about an hour after the first wave hit (Copyright DigitalGlobe)

The shockwave caused by the sub-marine earthquake off the west coast of Sumatra on 26 December 2004 generated a tidal wave that inundated the coastal margin of the countries bordering the Bay of Bengal (Fig. 1).

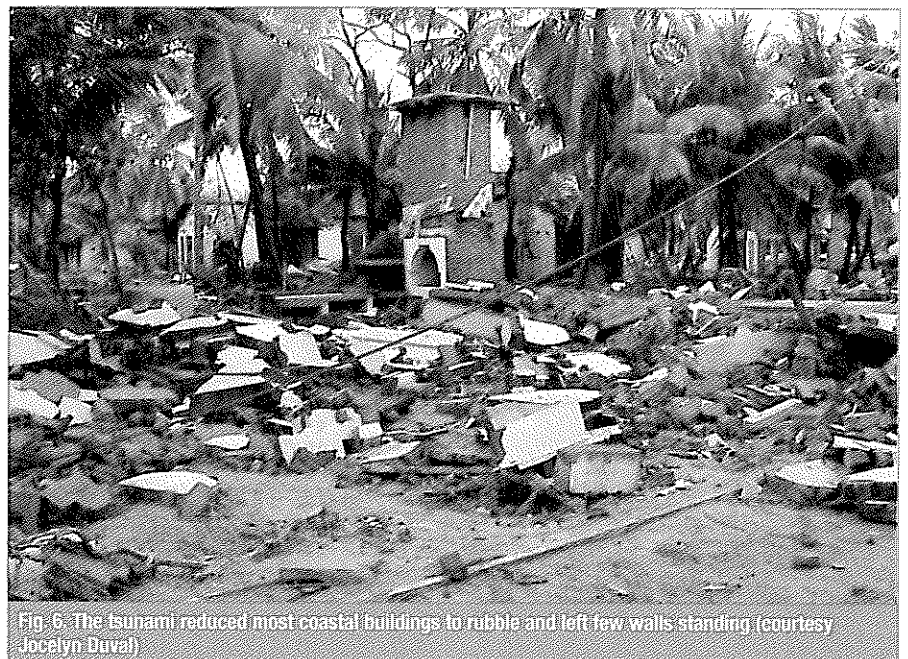
The waves generated by the tsunami inundated the coastal zone of the Ampara district to depths of up to 5 m and hundreds of metres inland of the coast. It reduced most buildings to rubble and left few walls standing (Fig. 6). Detritus was lodged in the branches of trees and filled wells. Piles of rubble lined the roads that had been cleared after the tsunami subsided to allow access. Mass burial pits were constructed in the destroyed area within days of the event.

Fig. 6. The tsunami reduced most coastal buildings to rubble and left few walls standing (courtesy Jocelyn Duval)

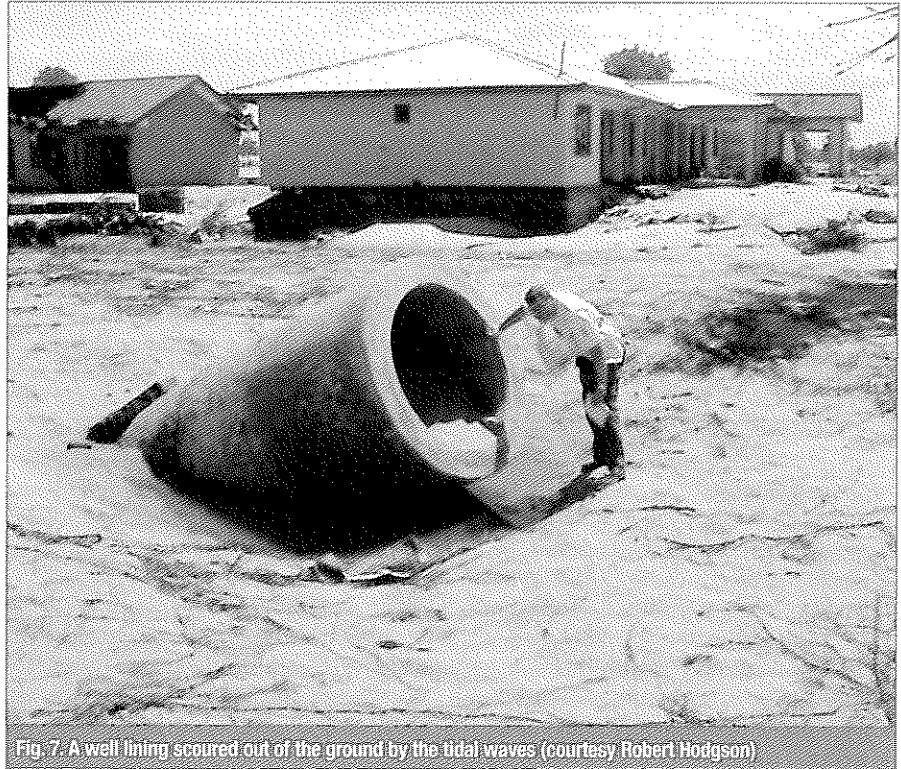
to one side and others still were entirely exhumed (Fig. 7) and lay on the surface. Of the surviving wells, those further from the ocean were protected from inundation by their upstand. Wells nearer the coast had been inundated by the overtopping wave that deposited varying amounts of debris in them (Fig. 8). Evidence of the narrow separation between toilet pits and wells is shown in Fig. 9.

Fig. 7. A well lining scoured out of the ground by the tidal waves (courtesy Robert Hodgson)

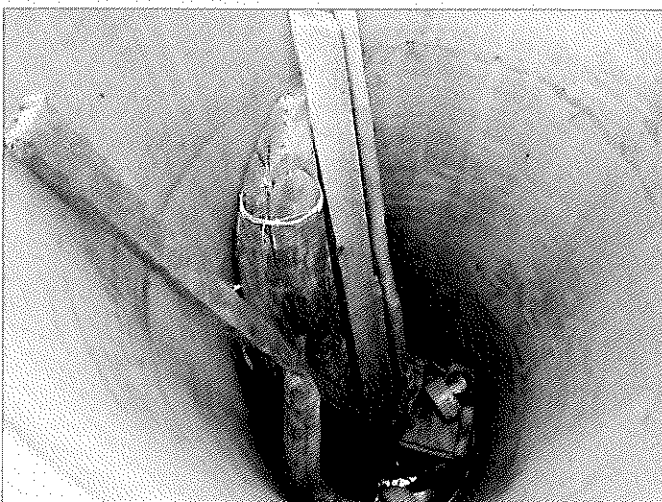
Fig. 8. One of the first tasks undertaken by volunteers was to remove debris and corpses from wells and start pumping out mud (courtesy Jocelyn Duval)

Whereas removal of debris and mud from the inundated wells was essential in the immediate aftermath of the inundation by the tidal wave, a proper evaluation and measurement of local conditions in the days and weeks following the tsunami would have demonstrated whether clearance pumping would be effective.

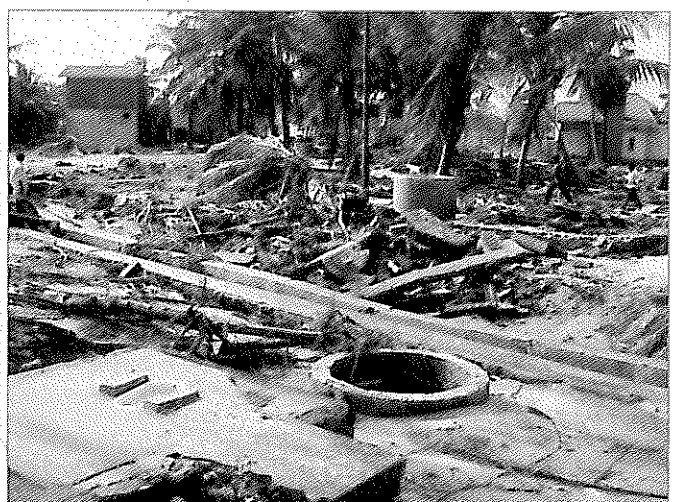
Each dwelling had its own domestic toilet pit that was sunk to a depth of up to 3 m and all washing facilities also drained nearby. The separation of the wells, or of the wells and toilet pits, was rarely more than 10 m. The vegetation consisted of some tall trees, including coconut palms, but little ground cover over the sandy soil.

Fig. 9. Toilet pits (foreground) are typically just a few metres from wells, adding further to aquifer contamination (courtesy Jocelyn Duval)

- separate permanently the water supply environment from that of the toilet pits.
