# Rural Water Supply Handpumps Project

## Laboratory Evaluation of Hand-Operated Water Pumps for Use in Developing Countries

Consumers' Association Testing and Research Laboratory

UNDP Project Management Report Number 2

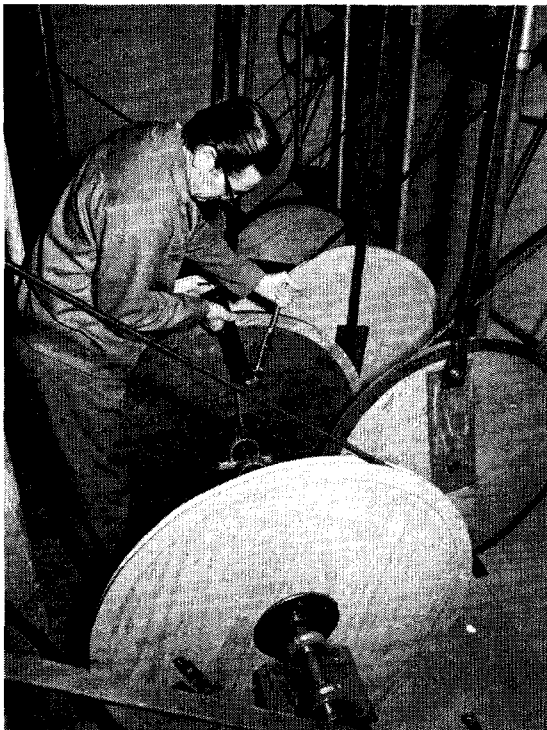
The endurance drive mechanisms

The floor beneath the pumps houses the mechanical drives for the endurance tests. Beneath that, each deep-well pump is fitted with a head simulation valve which is designed to simulate well depths down to 45 metres.

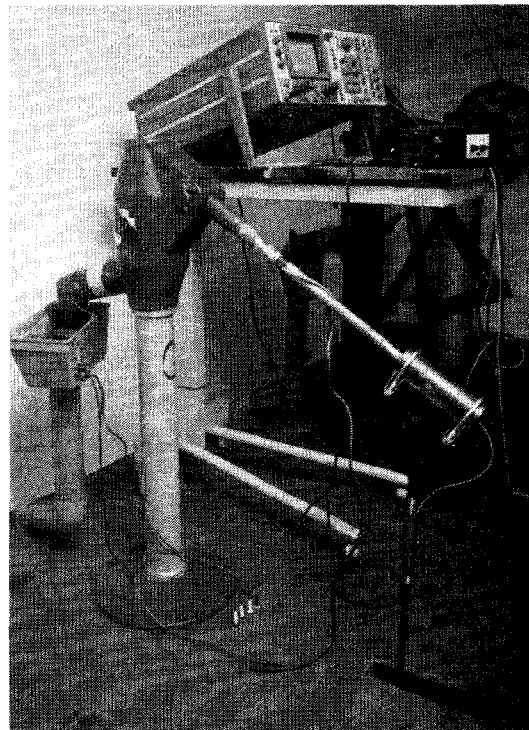
Handle shock test

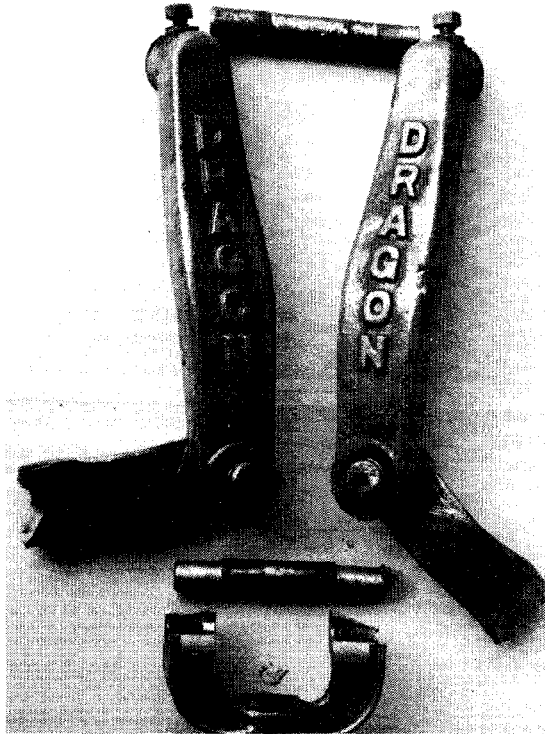
Wear on the handle fork resulted in breakage of the iron casting.

The pump failed at 2890 and 3207 hours when the pump rod broke within the thread at the top. Components of the handle mechanism including the gland nut had to be replaced after 2500 hours because of wear. The handle fulcrum had broken when wear allowed it contact the retaining bolt. At each intermediate inspection, the spout discharge valve was found to be seized through lack of use and was freed off.

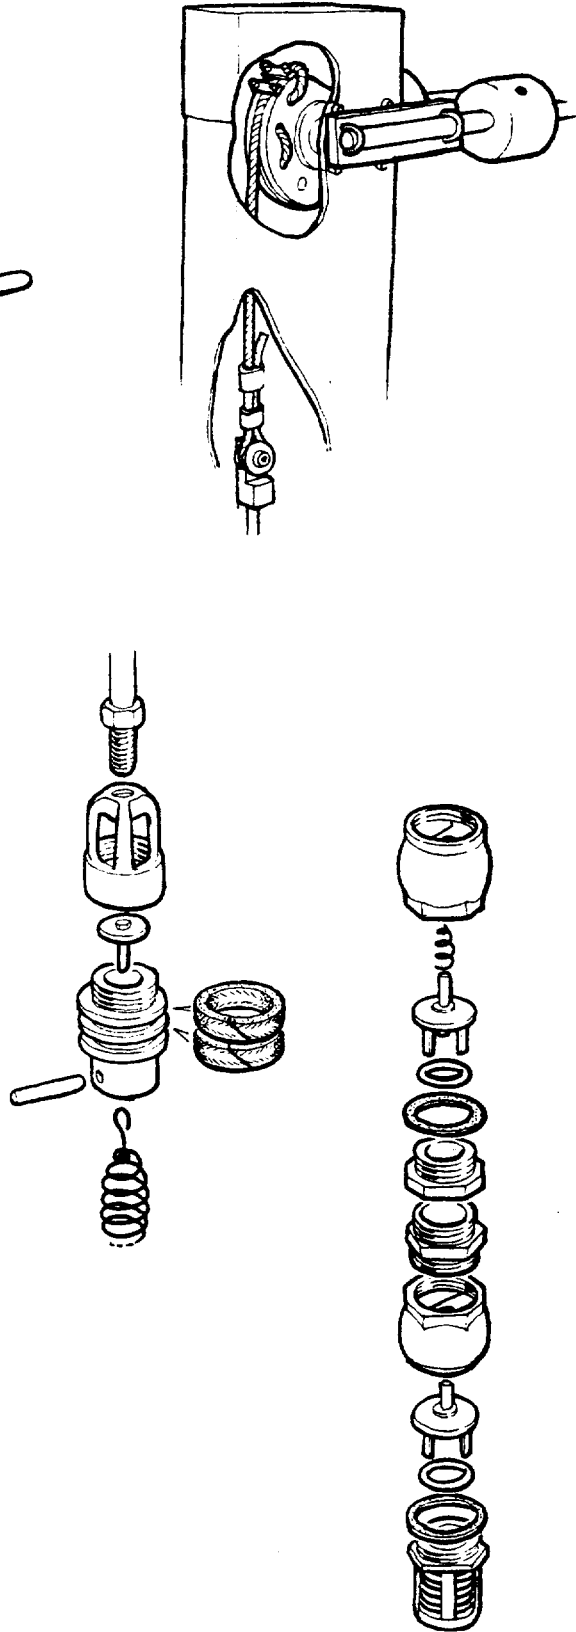
### 3.5 Code D

The Nepta is a deep-well force pump made in France. The pump-stand body is fabricated from sheet steel, the handle mechanism machined and fabricated from steel sections. The body is protected by a coating of nylon, the handle is galvanised. The pump rods are stainless steel attached at the top to approximately one metre of polyester cord, which wraps around a machined sector rotated by the handle.

The cylinder is seamless brass tube. The machined plunger uses two sealing rings of square-section textile cord in place of conventional cup seals. Tension in the pump rod and polyester cord is provided by a stainless steel spring attached to the bottom of the piston. Two foot valves are fitted, of similar design, each using a rubber O-ring seal.

The pumpstand weighs 41.5 kg, the cylinder assembly 15.5 kg and the pump uses 10 mm stainless steel rods within 1.25 inch nominal bore galvanised iron rising main. The maximum outside diameter of the below-ground assembly is 76 mm.

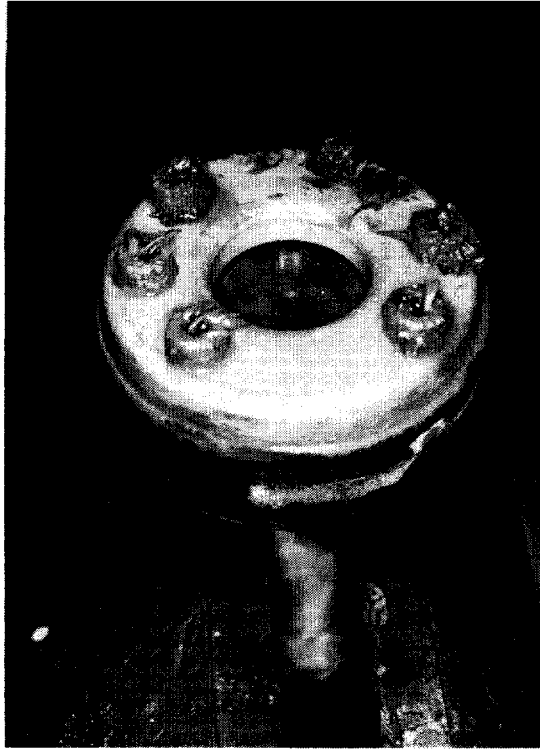
Original broken and corroded plunger  
fixing screws now replaced by stainless  
steel shouldered screws.

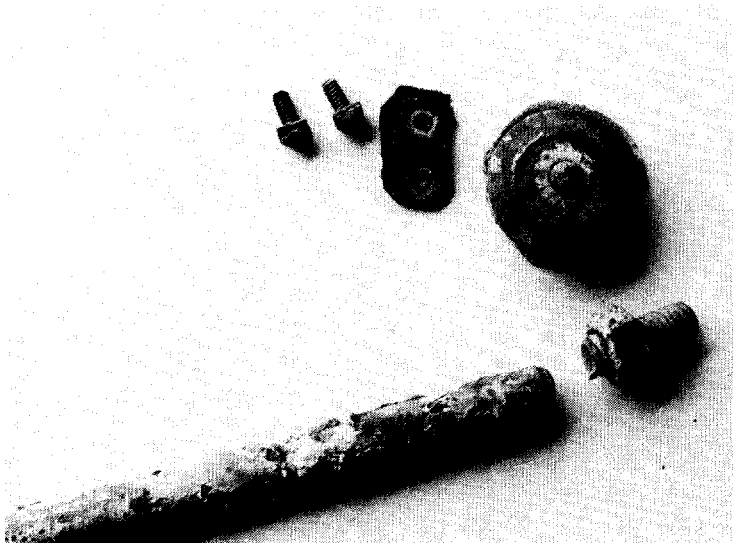
Corroded and worn foot valve components which resulted in breakage of the plunger rod.
