# Waste stabilization ponds in Tanzania

by Michael Yhdego

**It is claimed that waste stabilization ponds provide an efficient, inexpensive and appropriate form of wastewater treatment for developing countries. On the basis of negative experiences in Tanzania, Michael Yhdego disputes this claim.**

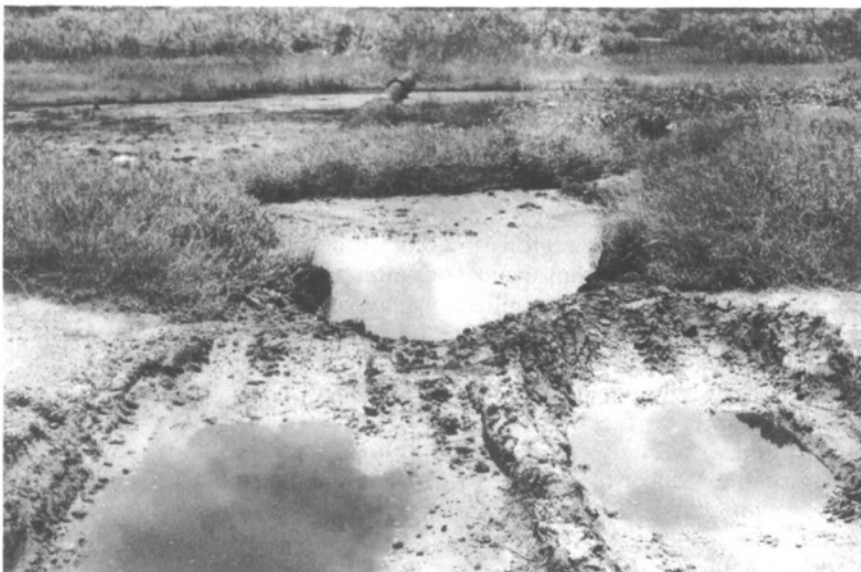
*A burst sewage pipe near a WSP encourages mosquito breeding.*

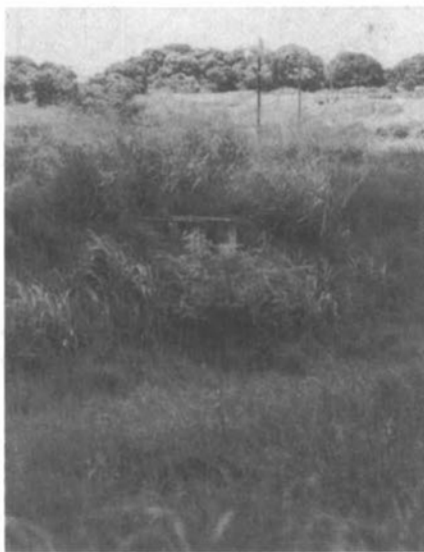
*A partially overgrown malfunctioning waste stabilization pond.*

There is a great deal of literature on the design of ponds and the removal of organic matter and pathogenic organisms, but no manuals giving guidelines on the operation and maintenance of pond systems are available in Tanzania. Generally, WSPs are able to continue in operation, making effluent fairly good quality even when maintenance is poor. Over time, however, they become overloaded with weeds and grass and deteriorate due to the lack of maintenance.
