Division of Building Research, CSIRO
Report 31

WATER STORAGE TANKS IN PAPUA NEW GUINEA
AND THE EFFECTS OF SEISMICITY

R.K.Hill and K.L.Biggs

1974

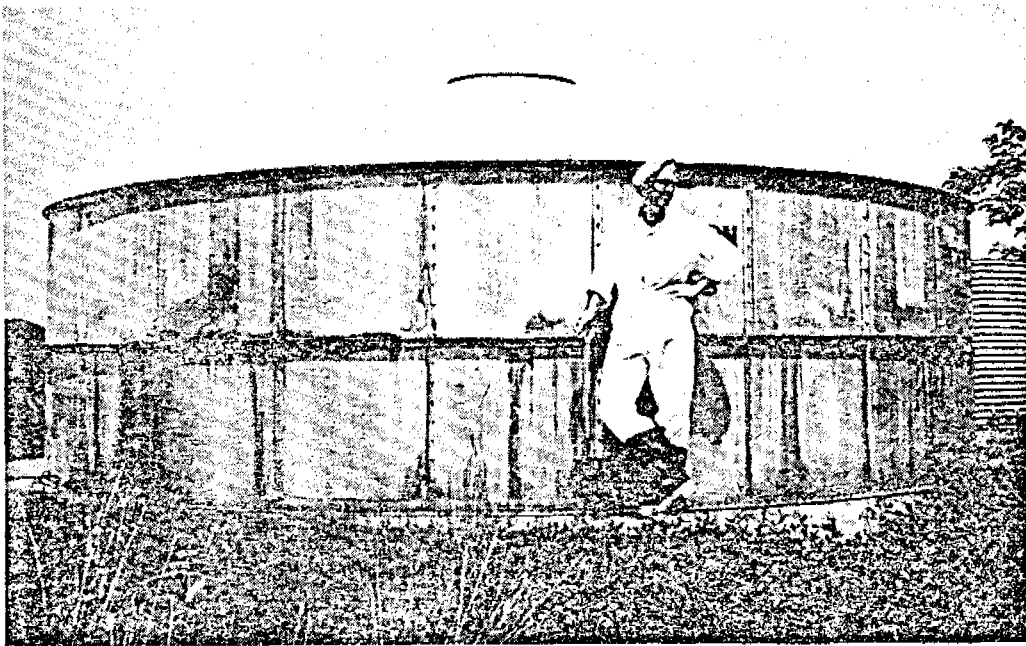
The standard material for tanks is a 0.56 mm (24 gauge) steel corrugated with a pitch of 76 mm (3 inch) and carrying a zinc coating of 550 g/m^2 (2.0 oz/sq.ft). Tanks are formed from curved sheets by rivetting and soldering the joints (Figure 3).

Fig.3 Corrugated galvanised iron tank showing rivet-and-solder join between sheets

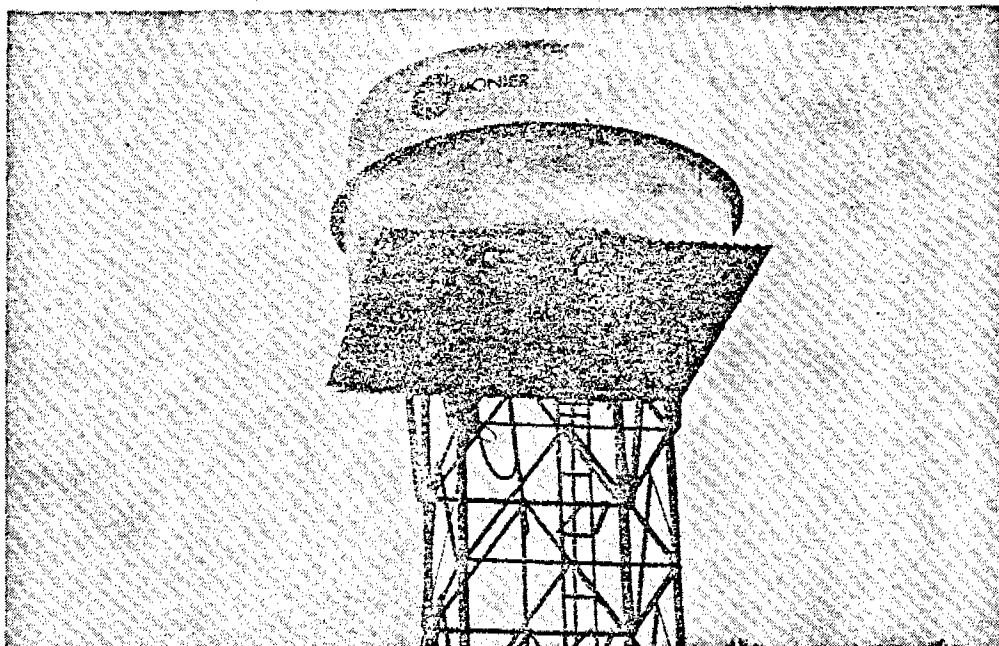
The Department of Public Works included a butyl rubber membrane tank (Fig. 6) in the 1971 tank comparison tests. Initially, water from the tank was considered to have a taste but this disappeared with use. The rubber walls of the tank apparently attract attention, and PWD had to repair a considerable number of punctures caused by pointed objects - including arrows.

Fig.6 Butyl rubber membrane tank showing method of support by galvanised steel mesh cage

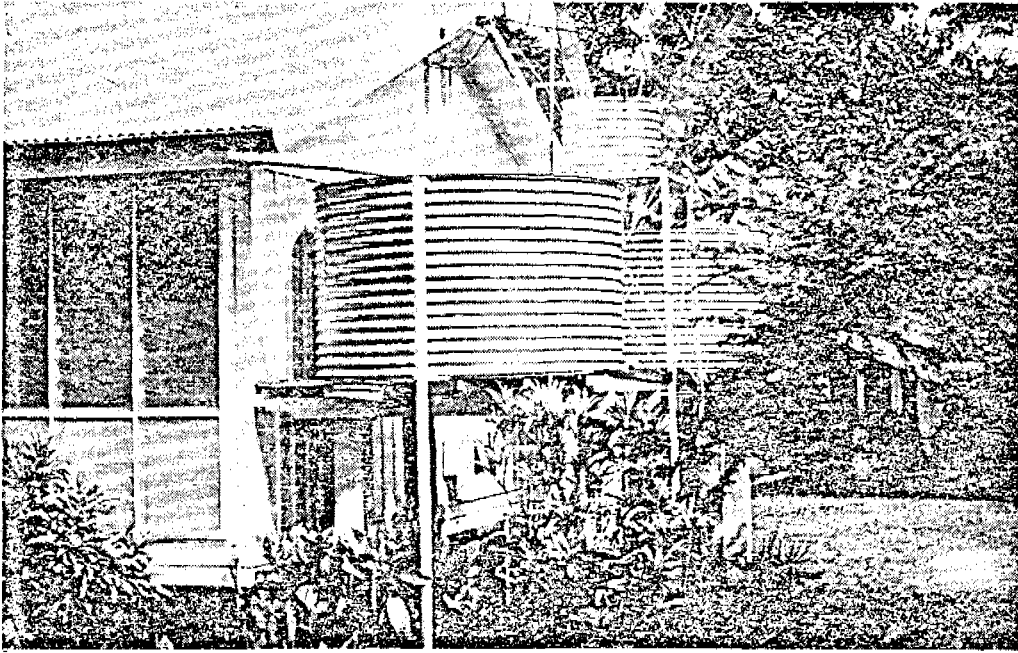
hole leakage caused by the jarring loose of protective corrosion products to the incontrovertible loss of the tank through being dashed to the ground with intermediate forms of damage comprising bursting of the soldered seams and the intriguing "concertina" collapse (Fig. 9).

Fig.9 Failure of a CGI tank by collapse of the corrugations

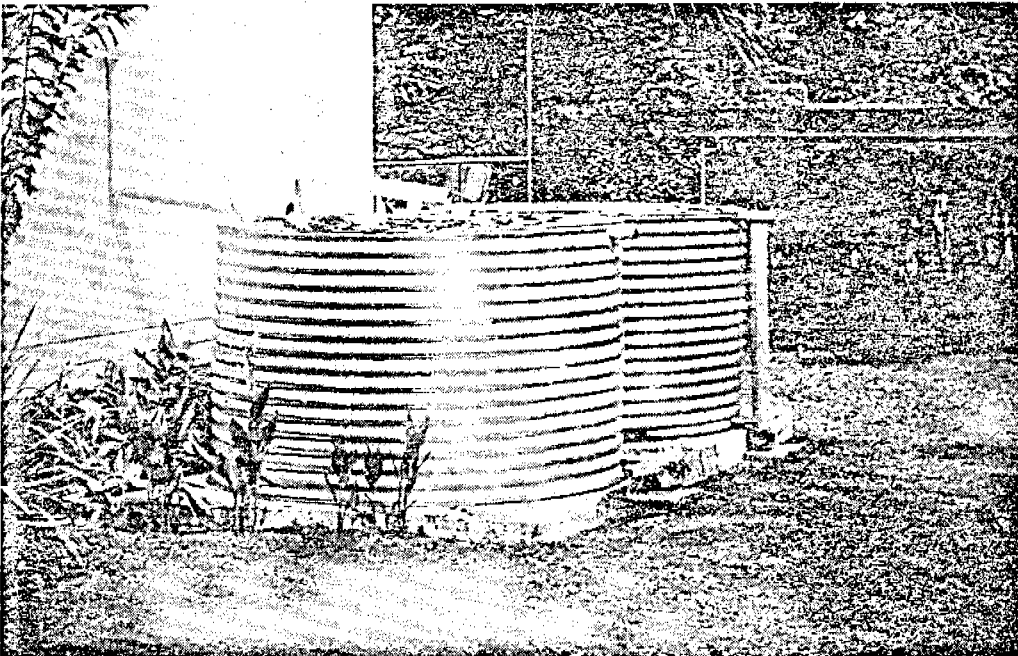
Houses are supplied either with a gravity feed system involving moderate elevation on a tank stand (Fig. 10) or an electric pump system which enables the tank to be placed at ground level on a concrete pad (Fig. 11).

Fig.10 Elevated tank installation at Lae. Supply of water to the house is by gravity.
