ENVIRONMENTAL HEALTH PROJECT

ACTIVITY REPORT

No. 70

**Dominican Republic: Evaluation of Rural Water
and Sanitation Infrastructure Construction**

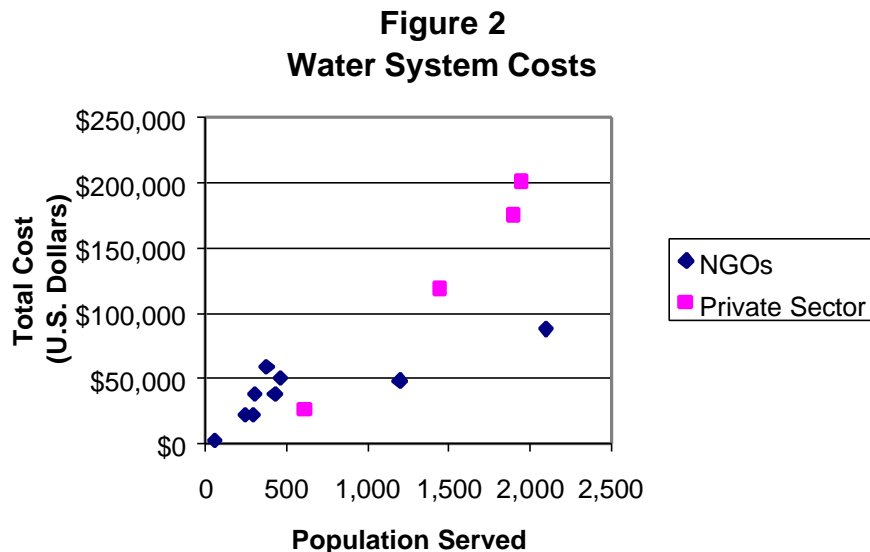
One of the questions that this evaluation attempted to address is, “With similar technologies, would it be more expensive to contract with the private sector or NGOs?” This question could not be satisfactorily answered based on a field evaluation because water systems contracted by NGO and Pro-Comunidad often serve a different population than INAPA projects. NGO projects typically serve more rural areas, often those with smaller populations, at times located in areas without electrical power. This fact is illustrated in Figure 2.

1 Locations of the Systems That Were Evaluated4
2 Water System Costs10
