Evaluation of the
Strategic Sanitation and Hygiene Promotion
-for Schools
Pilot Projects
Nkhata Bay and Kasungu Districts

LILONGWE
August 2004

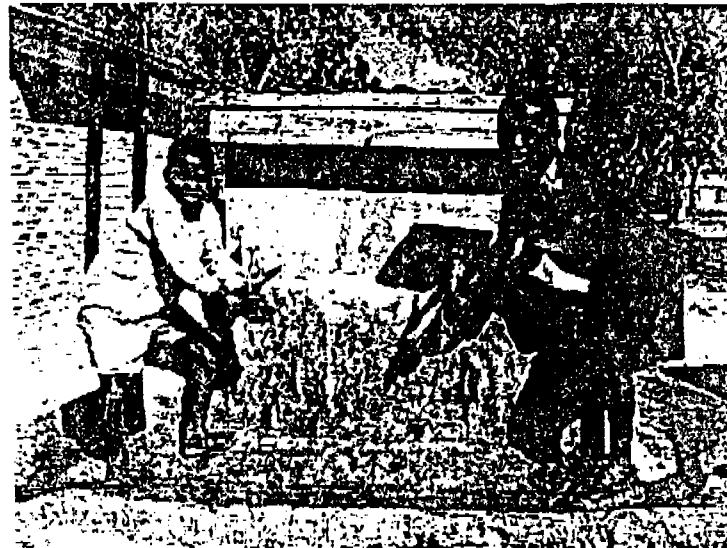
In one school there was a functional and sufficiently-large hand-washing tank for both boys and girls, but it was only being used by a minority of pupils. In this case, the reasons seemed to be related to prioritisation of hand-washing by teachers and the school committee. When asked, teachers and community members raised several problems including the lack of buckets and stolen/broken taps (three of the total of six taps on the two tanks were missing). But each of these problems are easily and inexpensively solved, especially in this school which is quite close to the town of Kasungu (taps and buckets each cost about \$3 to \$4. Similar problems were noted in other schools

Hand-washing in Chankhozi

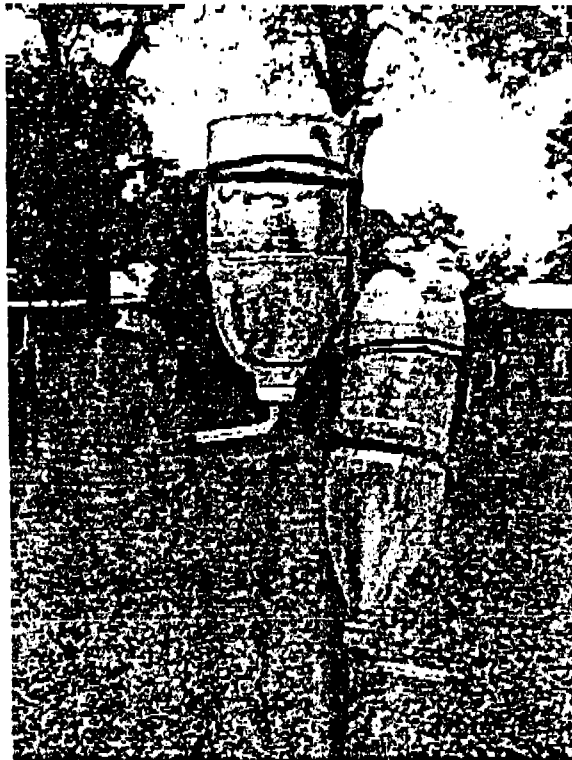
Demonstration hand-washing station at Chikvina School, Nkhata Bay

All schools visited opted for the more expensive concrete hand-washing tank over the leaky tin, which are neither replicable nor affordable for households. However, in some of the schools the Sanitation teacher and/or Sanitation Clubs made variations of the leaky tin and installed them as a way of promoting hand-washing stations in households. Several children indicated they had made their own versions and had installed them at home, however during the short visits to ten communities the evaluation team only saw two household hand-washing stations, only one of which was actually in use.

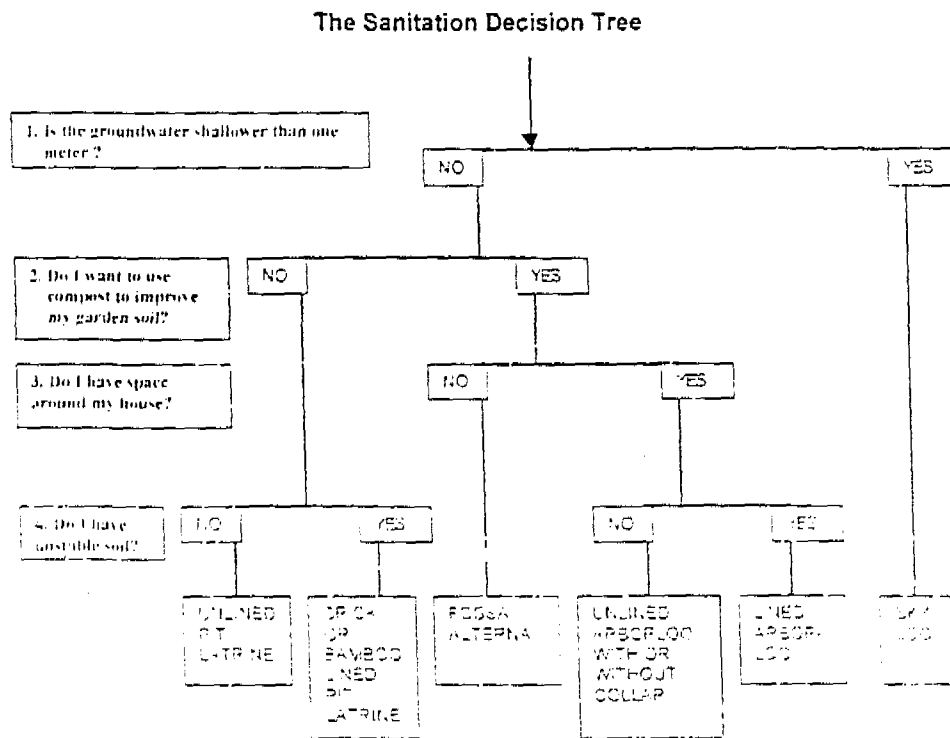
8.4.1 The Sanitation Decision Tree

Source: COMWASH project, Thyolo and Phalombe
