Shallow drum-lined wells for guinea worm eradication

by M.J. Ayotamuno, M.K.C. Sridhar, W.R. Brieger, A.Y. Sangodoyin, and P.N. Vyne

Treating ponds that are infested with guinea worm cyclops can be difficult in rural areas. A different and inexpensive method is to install a shallow, drum-lined well near the pond, so that the water is filtered through the ground before use, eliminating any cyclops that might be present.

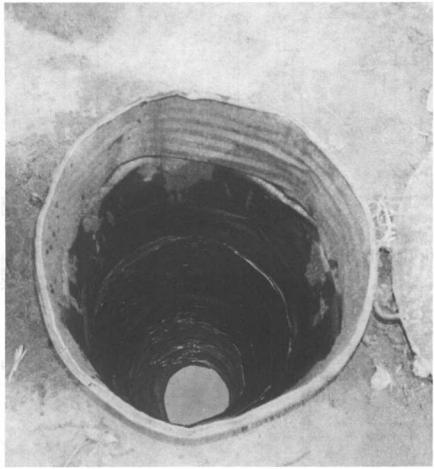
A shallow drum-lined well in situ.

In siting the wells, factors such as nearness to the pond, flatness of the ground, perviousness of the soil, and relative elevation to the pond were taken into consideration. Using simple tools, such as a long iron crowbar and a hoe, a pit is dug and a 1m-high oil drum which has had the top and bottom cut out of it and any dents flattened is inserted into the pit. Depending on the depth, two or three drums can be placed one on top of the other, and the gaps sealed with cement, but the use of more than three drums is not feasible. One of the tops or bottoms is used as a lid, to which a lock is fixed. After arranging the drums, the gaps between the lining and the pit are filled with either soil or a gravel and sand mixture.
